Analysis, presumed structure, method and time of fabrication of the Baalbek trilithon and “tired” parallelepipeds

Rostislav V. Lapshin

Kurchatov Institute

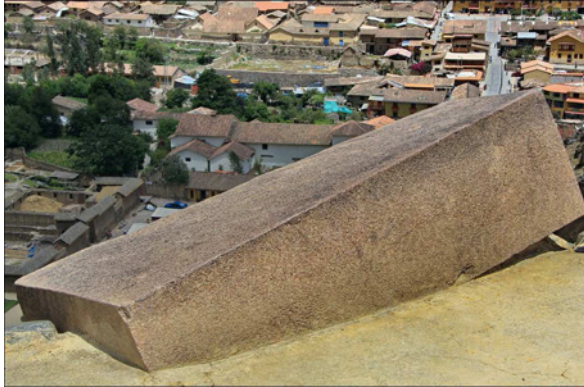
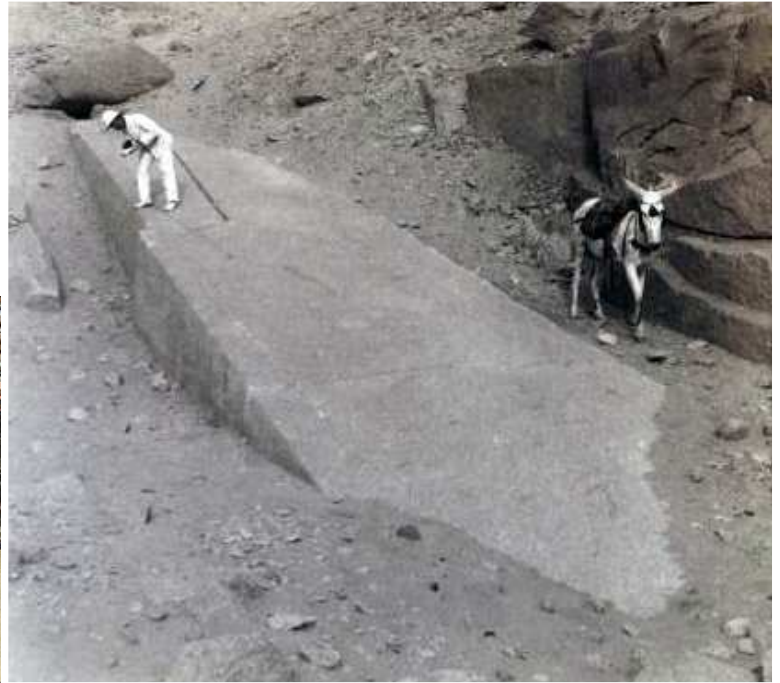
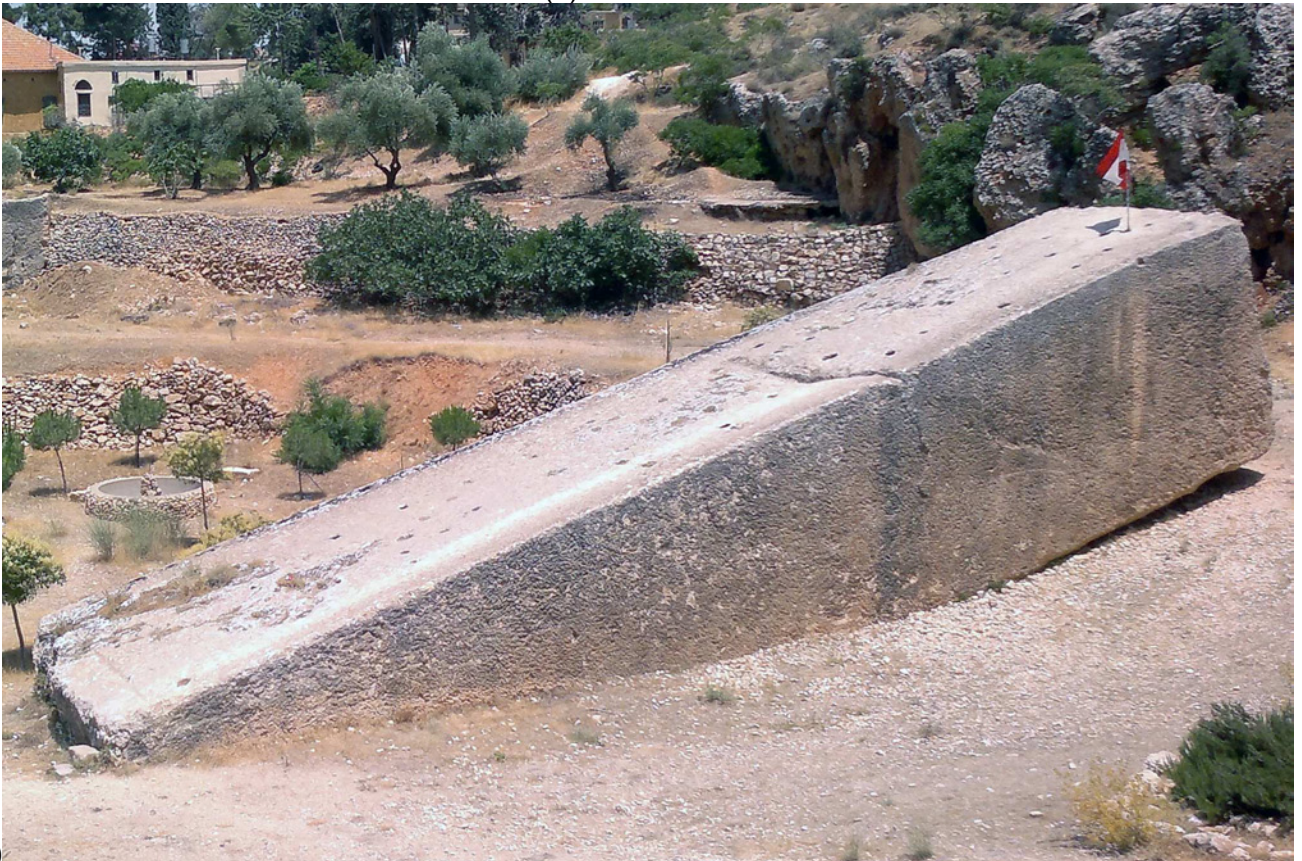
Photo. 1. “Tired” (a) parallelepiped at the Archaeological site of Ollantaytambo, South America; (b) Unfinished Obelisk in Aswan, Africa; (c) Baalbek parallelepiped – the “Stone of the South”, Middle East. All three monuments are suspiciously similarly positioned in space – they are inclined to the surface at a small angle (about 11° in the case of the Obelisk and about 16° in the case of the parallelepipeds) and are partially embedded in the ground at one end. The orientation of both parallelepipeds is toward the northwest, approximately at 11 o'clock. It gives the impression that all three stones had the same landscape designer. Photos (a) E. Berzin, 2015, allenatore.livejournal.com; (b) Underwood & Underwood, 1904, digitalcollections.rice.edu; (c) 2011, wikimedia.org.

Moreover, the upper concrete layer of the tired parallelepipeds also features either a transverse fold or a quite distinct transverse boundary (see Photo. 1c, Photo. 2, Photo. 3, Photo. 4), dividing it into two parts. In the case of the Stone of the South, for example, it is clearly visible that the transverse fold on the upper face continues onto the southwest vertical face and then descends along this face at an angle toward the base (see Photo. 1c).³¹ The transverse fold in question formed because the concrete pouring, due to its relatively large volume, had to be carried out in two stages. Initially, the lower half of the parallelepiped (the one situated lower on the slope) was poured first, followed by the upper half.

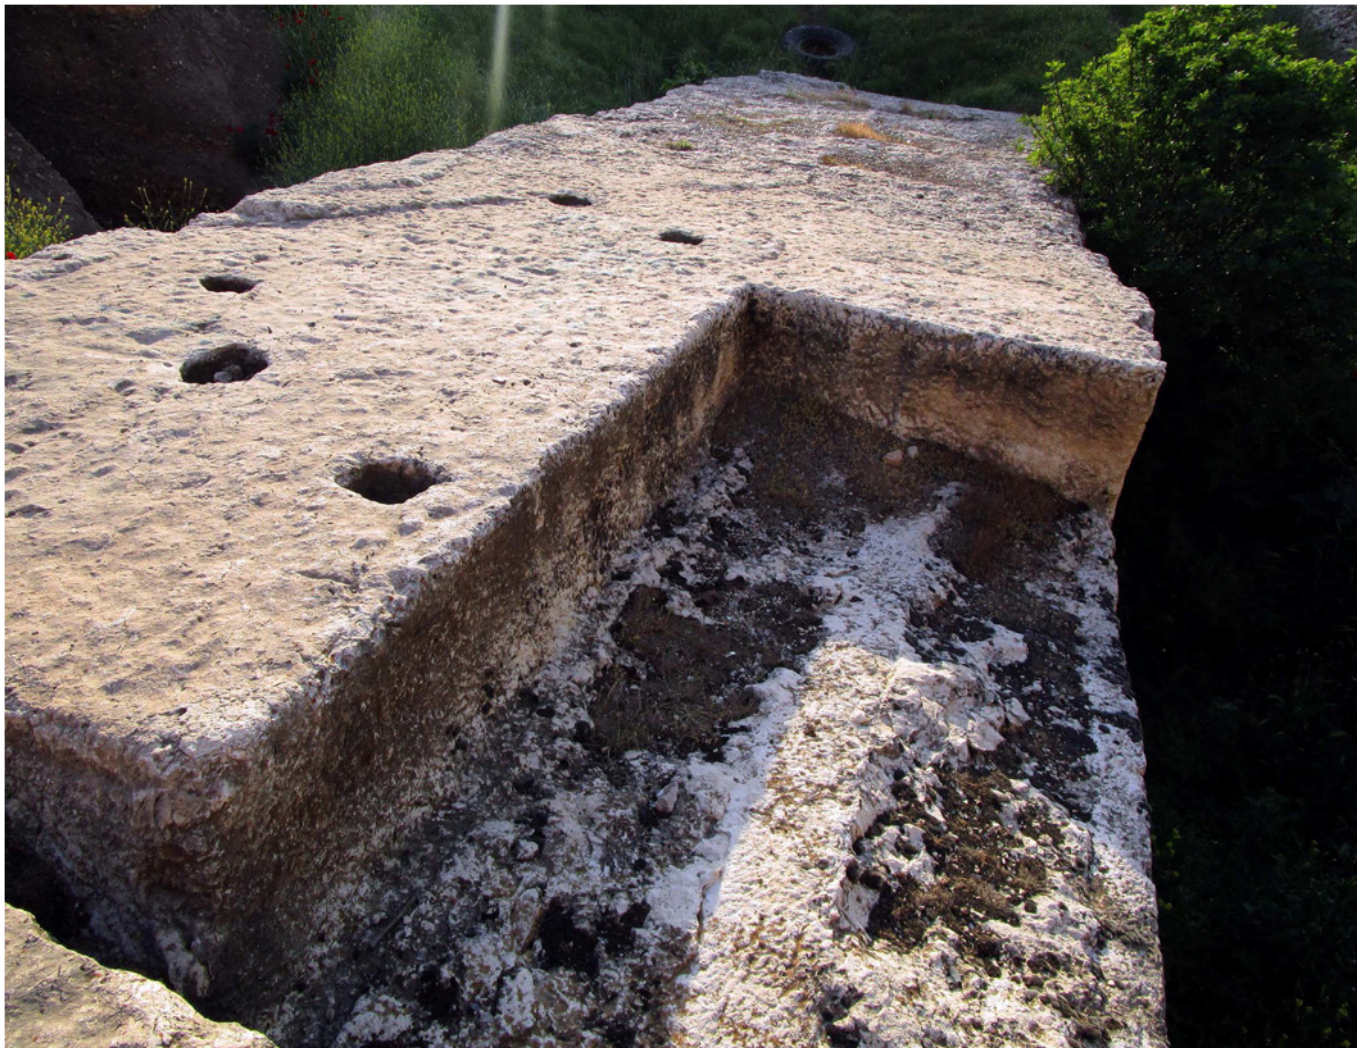
(a)

Photo. 2. The West Stone weighing about 1,300 tons and its inner “stuffing”. Characteristic round and square pits are visible on the upper face; these formed at the locations where the walkway supports stood, from which the concrete was poured and compacted. The walkway supports also served as restraining elements to prevent the concrete from sliding during the pouring of the upper inclined face. At the location of the cut-out block, the outer vertical wall of the concrete box and the internal concrete partition parallel to it are clearly visible. The concrete partitions form when concrete fills the spaces between masonries of stone blocks (the dark rectangular areas) laid inside, which constitute a core of the “monolith”. The stone blocks of the core act as rigid aggregate, significantly reducing the required volume of concrete, greatly simplifying the formwork, and dramatically decreasing concrete shrinkage, thereby preventing the formation of shrinkage cracks. Photo 2019 from wikimedia.org.

On the upper faces of the tired parallelepipeds there are round and square pits (see Photo. 2, Photo. 3, Photo. 4) exactly the same as those on the upper faces of the trilithon blocks (see Photo. 13) and on the upper faces of the plinth blocks (see Photo. 21). The mechanism behind the formation of these pits has already been described in detail above. Since the upper faces of the tired parallelepipeds were poured at an incline, the walkway supports – which are the cause of these pits – served as an additional means of preventing the concrete from sliding down.

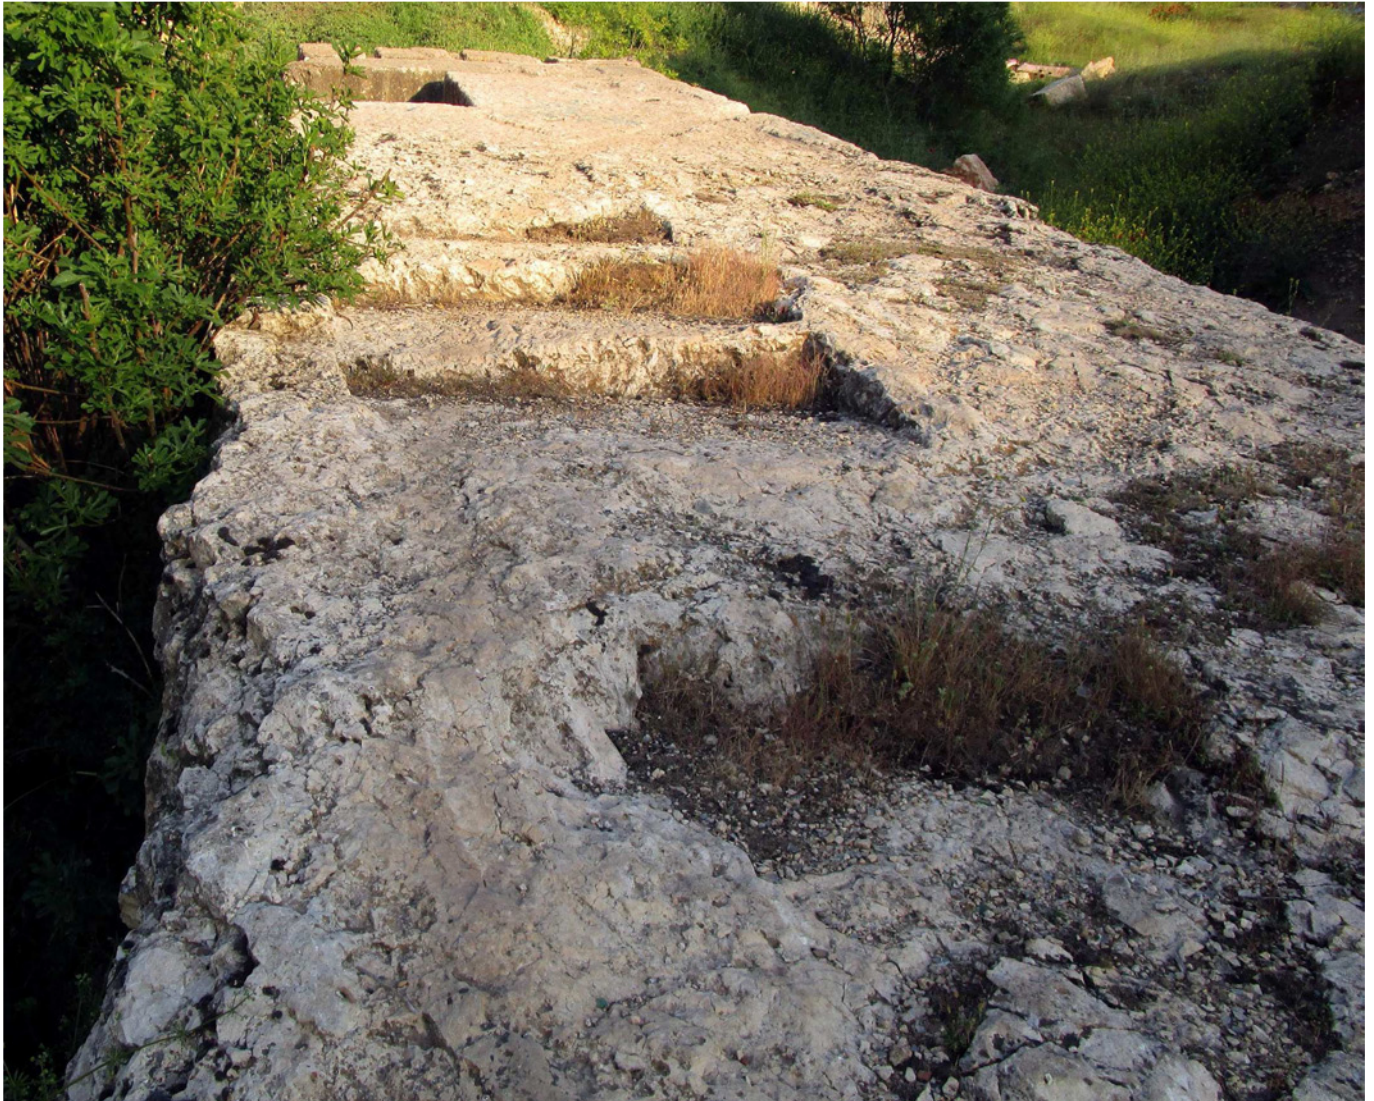
(b)

Continuation of Photo. 2. Strange wedge-shaped notches making steps on the upper face. The steps are formed by the upper blocks of the inner masonry. The steps served to keep the concrete from sliding down during the pouring of the upper inclined layer. Over time, the top concrete layer disintegrated, revealing the stepped structure underneath. Since the steps run along one half of the “megalith”, similar steps are most likely present under the top concrete layer on the other half, where the concrete adhesion to the inner masonry turned out to be stronger. It follows from the observation that the inner masonry of the “monolith” consisted of two parallel stone masonries. The well-preserved side walls in the wedge-shaped notches also support this conclusion. A clear boundary runs across the West Stone dividing it into two parts. Such a division indicates that the concrete was poured in two stages: first one (lower) half of the “megalith” was cast, and then the other (upper) half. Photo 2019 from wikimedia.org.

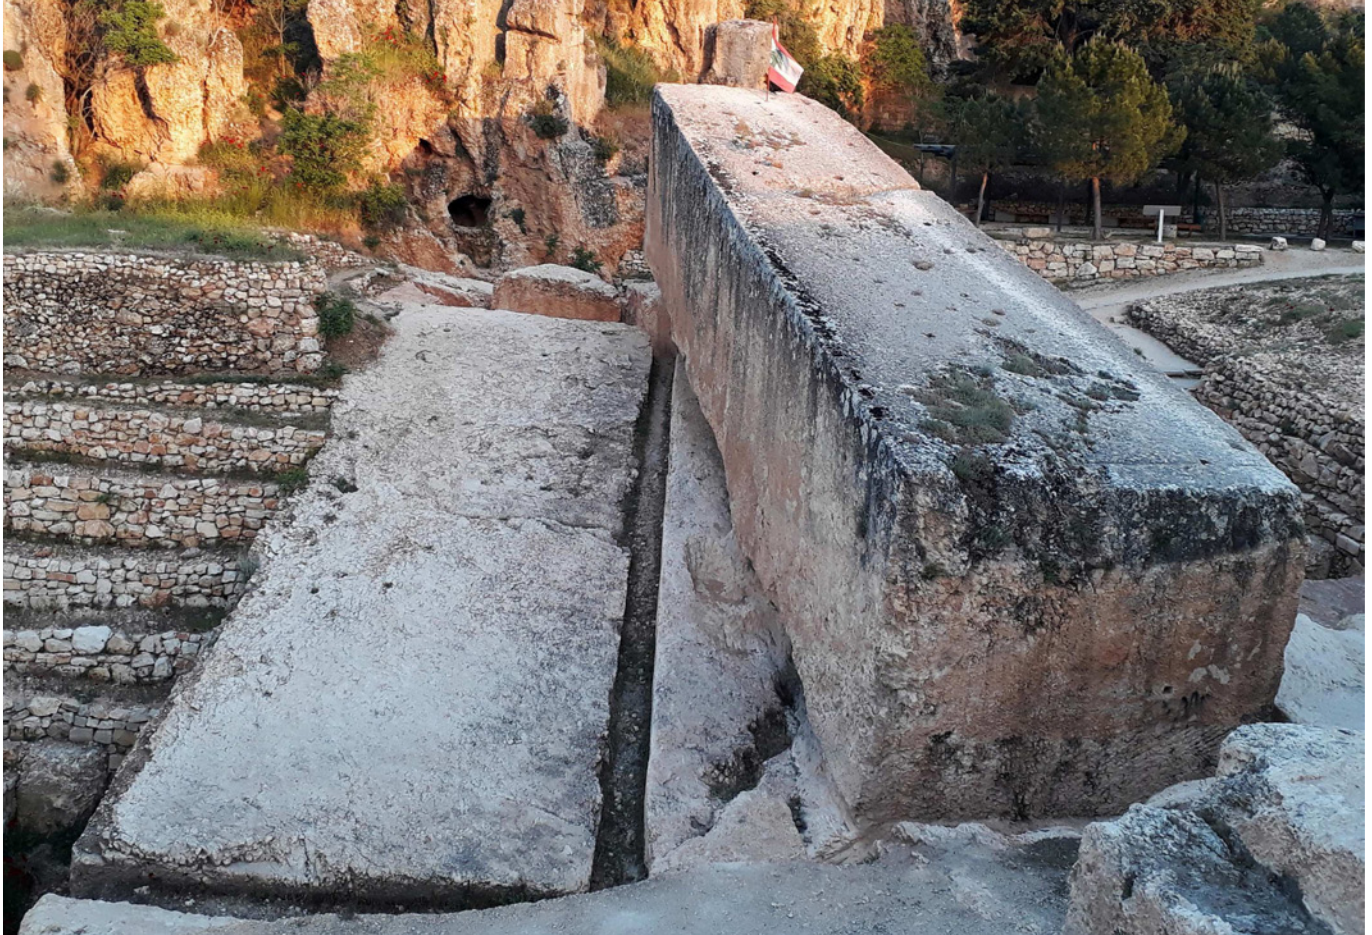
Photo. 4. The Newly-acquired Tsar Parallelepiped (left) discovered next to the Stone of the South (right). The estimated weight of the excavated megalith is a record 1,650 tons. Just like the West Stone and the Stone of the South, the upper face of the Newly-acquired Parallelepiped shows the following signs of concrete casting: pits, a clearly visible top layer, and a transverse fold in the top layer. The composition of the parallelepipeds carries the symbolism of 9 (Roman numeral IX). Photo 2019 from wikimedia.org.

In real quarries, both then and now, stone extraction is carried out in successive layers of blocks.² To move on to the next layer of blocks (see Photo. 4), one must first finish the current one. But how can one finish the current layer of blocks without removing a defective block or block (in our case, the Stone of the South) that the customer refused? Why did the ancient builders undertake the preparation of the Newly-acquired “Tsar” Parallelepiped (see Photo. 4) – after all, it lies directly in the path of transporting the Stone of the South⁸ to the Baalbek construction site⁹?

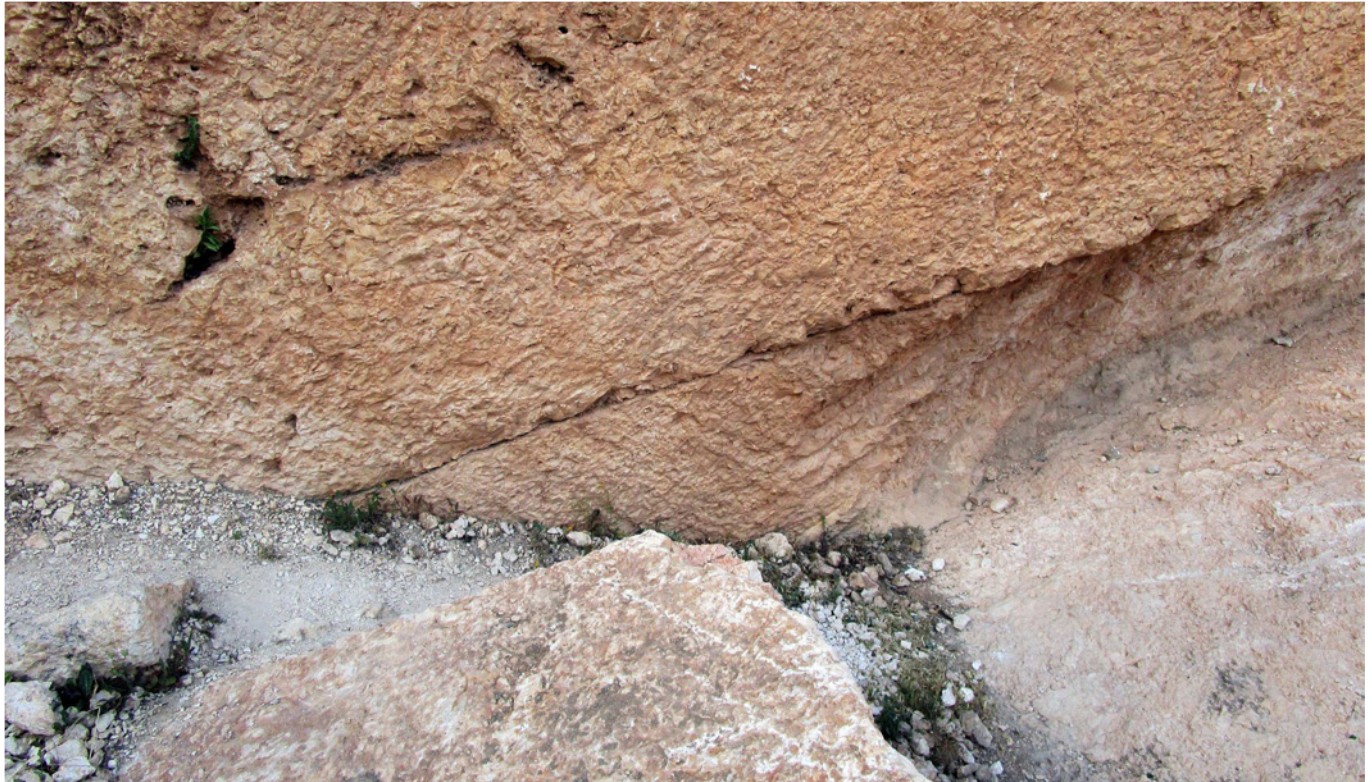
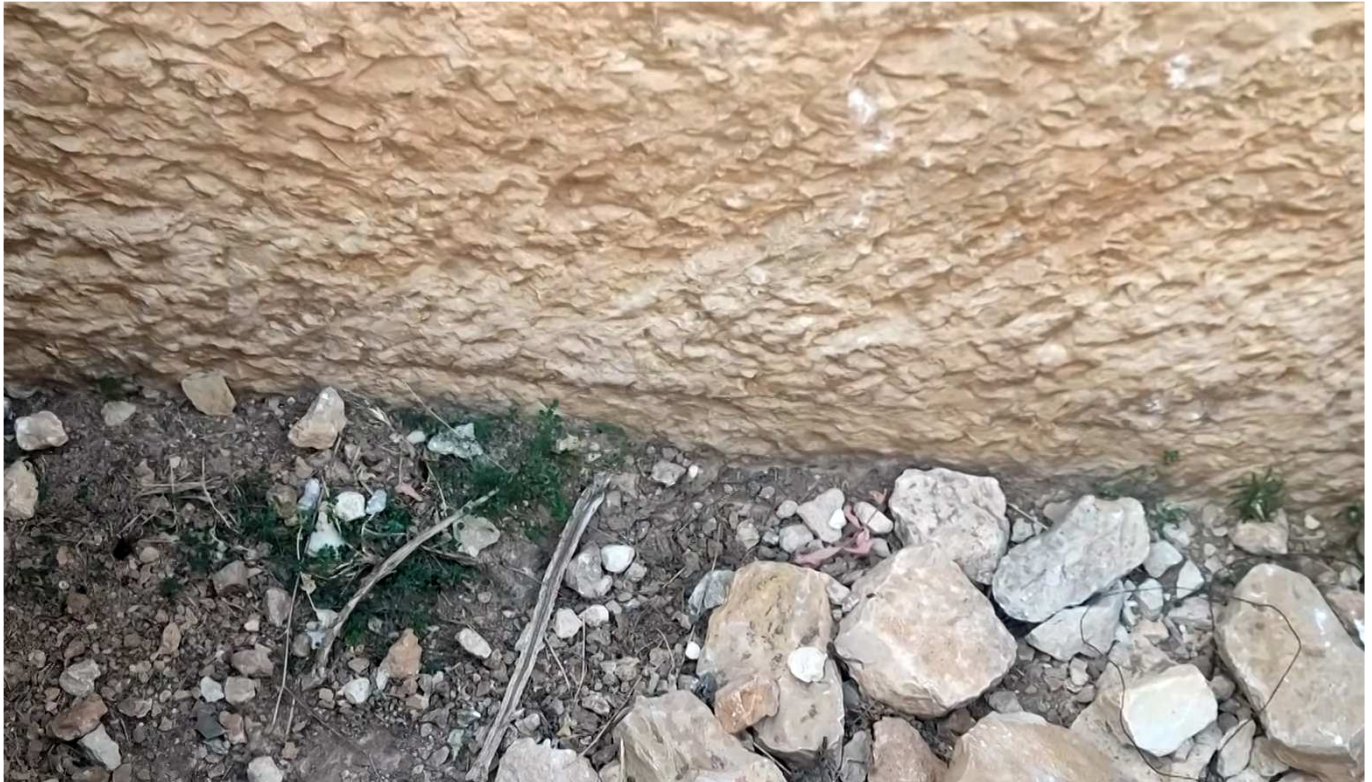
Photo. 5. Section of the “very long crack” under (a) the Stone of the South, (b) the Newly-acquired Tsar Parallelepiped. The planes of the vertical faces of the monoliths and the vertical planes of their bedrocks coincide and are processed to the same quality (the excavation of material in the bedrock under the Stone of the South, which produced the rough, deep grooves, was performed later). The planes of the cracks are parallel to the upper faces of the megaliths. Photo 2019 from wikimedia.org.

Continuation of Photo. 5. Frame from the video “Lebanon, Baalbek”, 2024.

depth at which this crack lay and the spatial orientation of its plane. Why, then, didn't the German archaeologists consider the Newly-acquired Tsar Parallelepiped defective for the same reasons? After all, exactly the same kind of crack¹¹ was found beneath it (see Photo. 5b) as under the Stone of the South.

South and the Newly-acquired Parallelepiped exactly coincide with the vertical planes of the bedrocks beneath them. Moreover, the vertical faces of the megaliths and the vertical planes of their bedrocks are originally processed with the same high quality (for some reason, there are no rough grooves typical of stone blanks left by pickaxe use on the walls). Besides other things, both of these facts indicate that the crack in question did not come as a surprise to the builders.

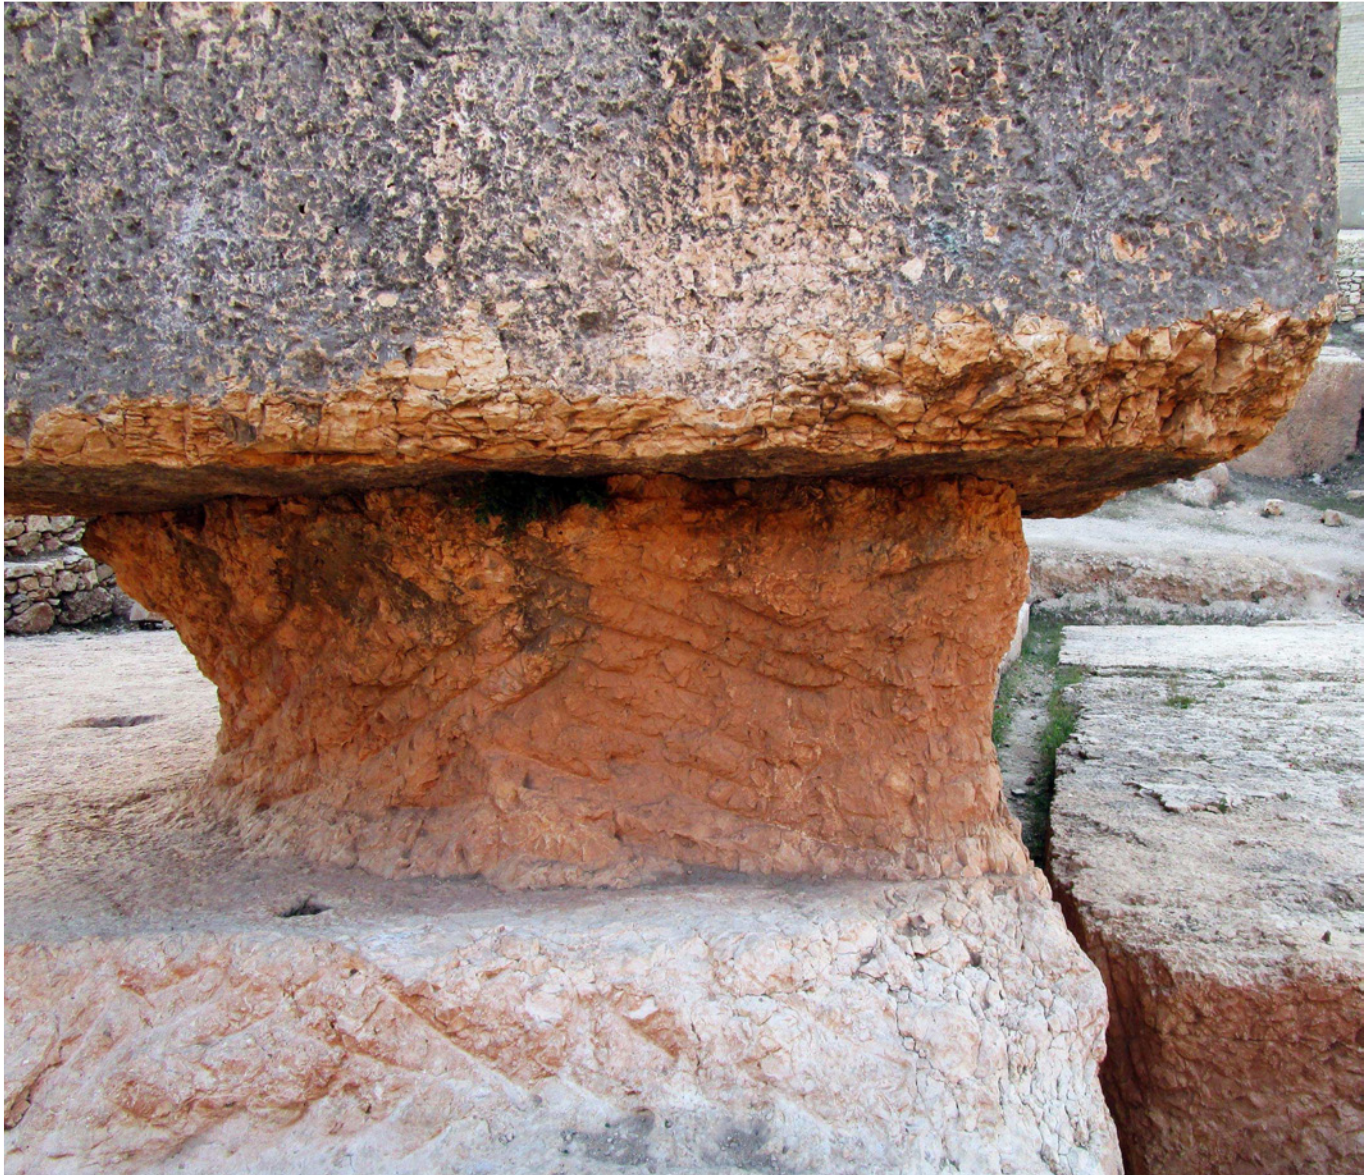
Photo. 6. Deep, rough grooves mark the walls of the elegant pedestal, which today supports the 1,000-ton Stone of the South. No need to worry – the German archaeologists cleared away the soil and slightly cut the pedestal in places, but they had everything calculated. Now, during heavy rain or a small earthquake, “Humanity’s World Heritage” has a good chance of falling on its side. Where is UNESCO watching? It looks like everything is ready for some kind of nasty show. But every cloud has a silver lining. After all, should the tired parallelepiped fall from its pedestal, it may break apart – revealing its true inner stuff to us. Photo 2019 from wikimedia.org.

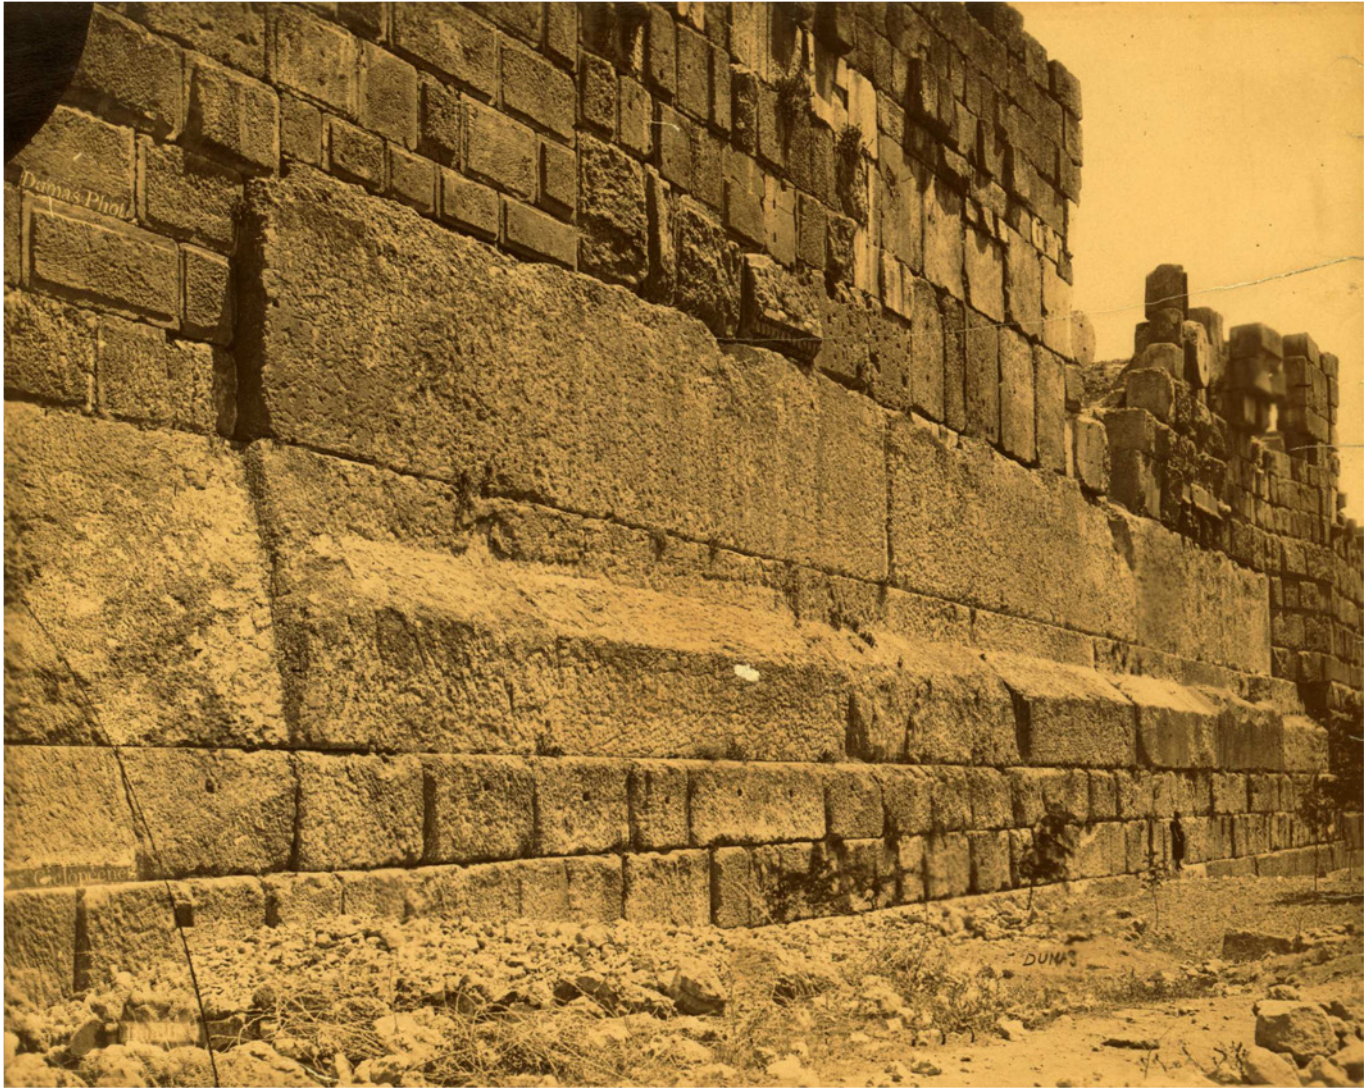
Photo. 8. Three “trilithon” blocks and a course of large plinth blocks below them on the west side of the Temple of Jupiter. The trilithon blocks are estimated to weigh 800 tons, and the plinth blocks 350 tons. Since the three courses of stone blocks of the fortress wall rest against the ends of the trilithon blocks on either side, the regular bonding pattern is disrupted in these places, thereby increasing the chances of wall collapse on both sides during an earthquake. In addition, in two other locations, the stone blocks of the wall above the trilithon blocks (north and south) are laid with gross violation of the bonding rule. How could the indicated bonding violations occur if the fortress walls were erected much later than the temple podium? Photo by T. R. Dumas, 1860, loc.gov.

Besides the places already mentioned, the bonding rule of the blocks is grossly violated at two other locations in the wall above the trilithon blocks. Photo. 8 and Photo. 10 clearly show the breaks in connections extending through the entire height of the wall, situated respectively above the north and south trilithon blocks. To survive earthquakes, which are not uncommon in the region, or even strong gusts of wind, the unbonded stone blocks above the south trilithon

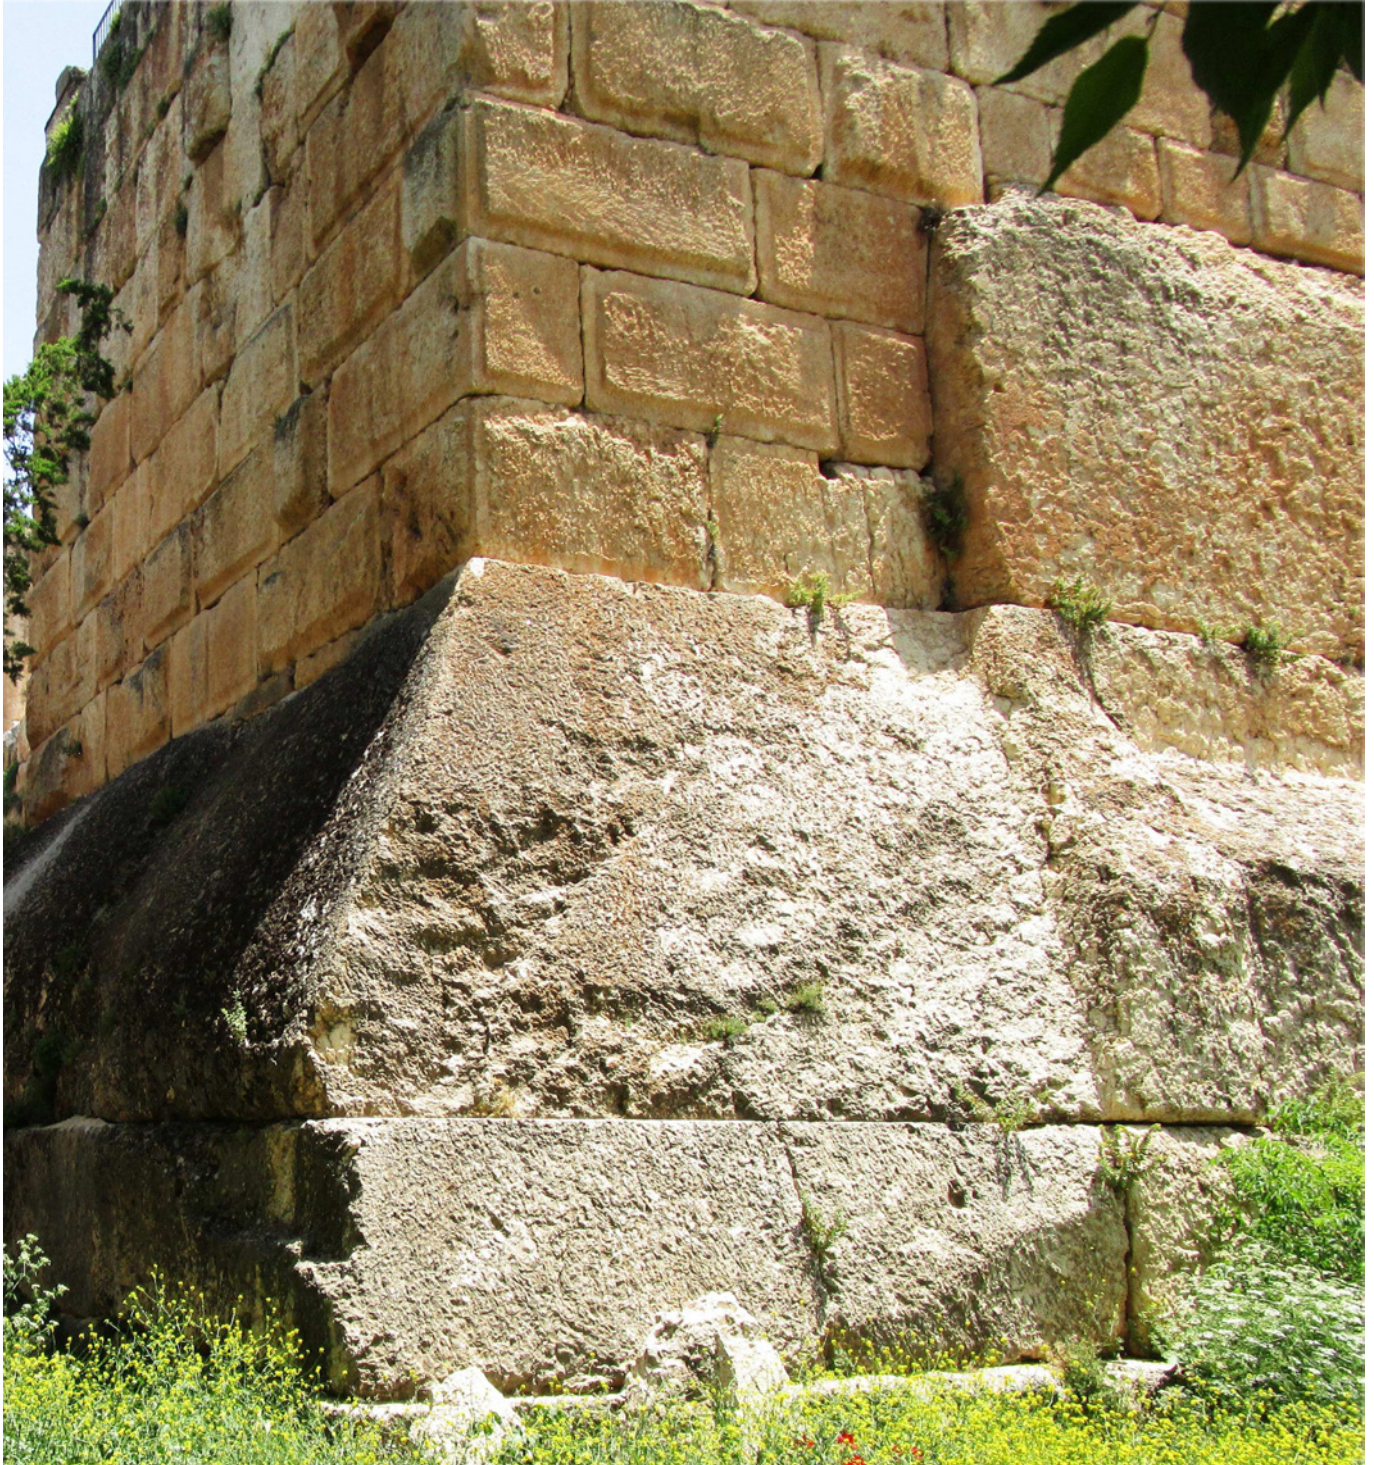
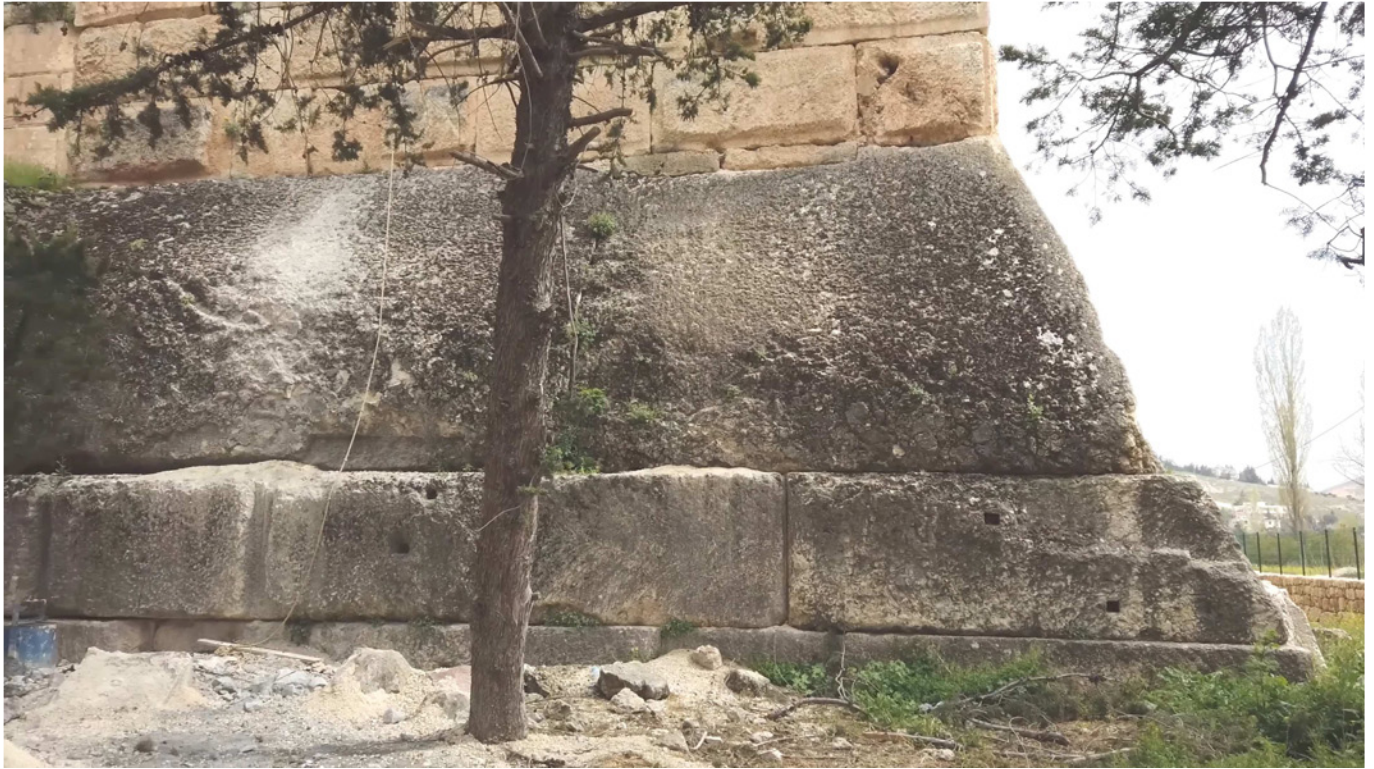
Photo. 9. Northwest corner of the Temple of Jupiter. (a) The front side of the north trilithon block protrudes noticeably outward for some reason, although it seems as if nothing prevented the stones of the fortress tower from being put flush with this block. The large plinth block under the trilithon block also protrudes noticeably outward from the wall plane. What are the reasons for the observed protrusion of these blocks? Photo 2019 from wikimedia.org.

Continuation of Photo. 9. (b) On the north side, near the corner and under the conditionally first course of the wall masonry of the fortress tower, some inserts consisting of two small stone blocks are visible. These inserts, together with the peculiarities of the masonry of the courses of blocks beneath the plinth blocks, allow us to conclude that the stone blocks of the fortress tower do not rest on the plinth blocks at all. The latter are simply abutted against the tower wall, whereas they should at least partially extend beneath the wall. It turns out that the plinth blocks are a fiction, as they bear no weight load whatsoever and do not perform the function of diverting rainwater flowing down the wall away from the wall footing. Frame from the video “Inside the massive ancient megalithic complex of Baalbek”, 2022.

On the northern side of the fortress tower, near its northwest corner, slightly above the horizontal edge of the corner plinth block, beneath the conditionally first course of masonry, some two strange stone inserts can be seen (see Photo. 9). These inserts resemble the two strange blocks whose tops protrude from behind the front concrete face of the middle trilithon block at the place where a small fragment has broken off from the face (see Photo. 12). Most likely, these inserts were required due to the settlement of the wall masonry at this location of the tower. The settlement itself was caused by the washing out of the foundation by rainwater running down the wall. The washing out occurred because the “plinth” blocks were not properly recessed into the wall, as is standard in construction, but were simply cast directly against it.

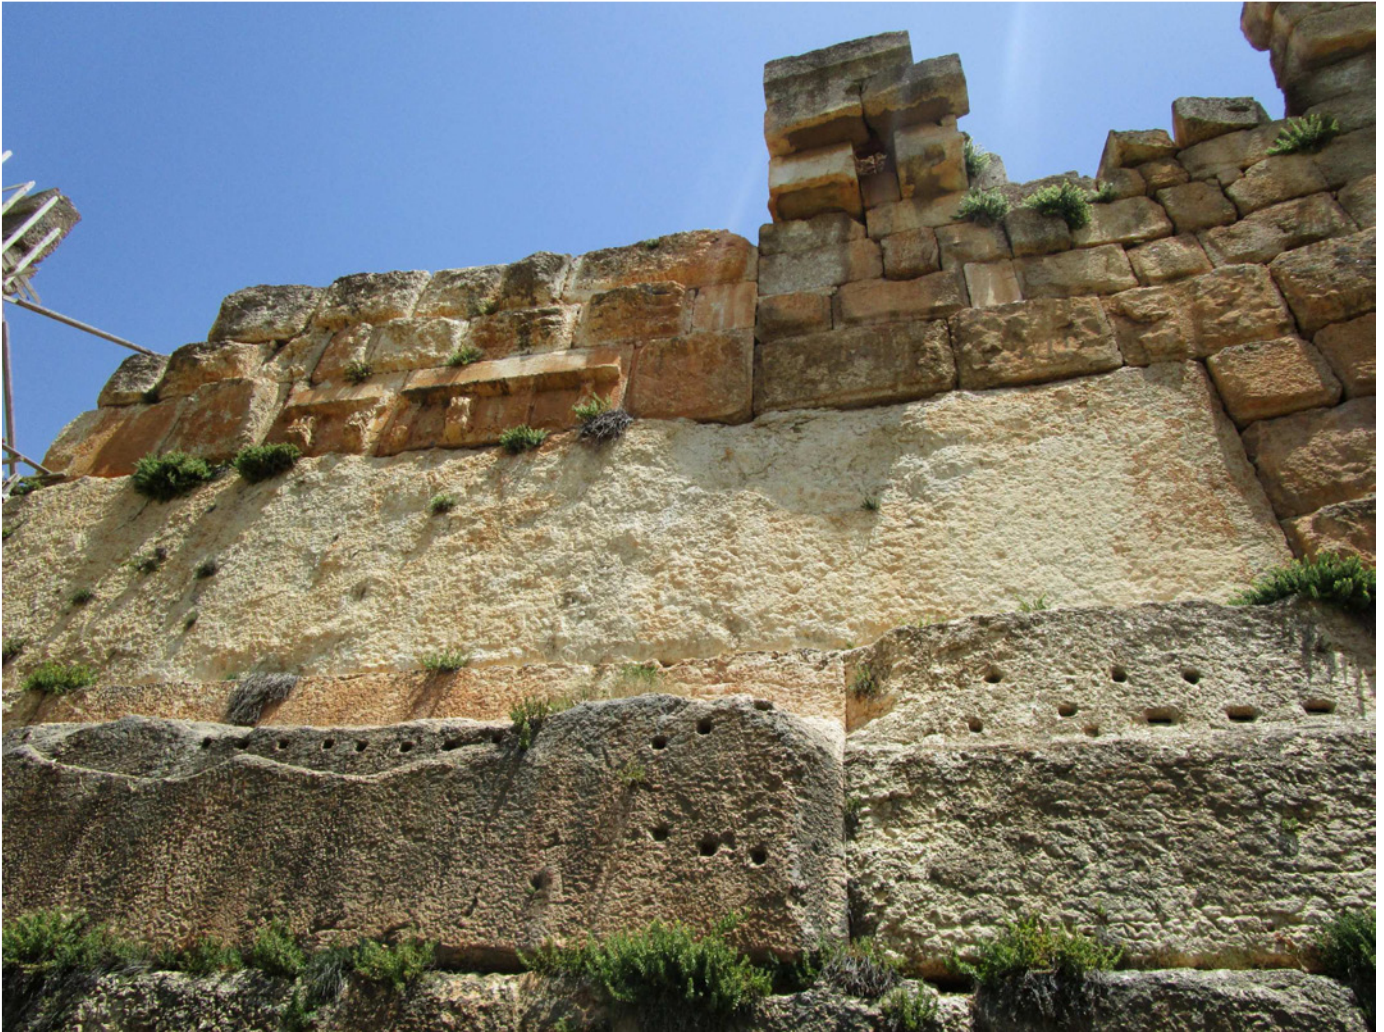
Photo. 10. The south trilithon block. A significant portion of the outer concrete layer has already fallen away; soon the internal contents of the “monolith” will be exposed. Humanity's World Heritage is in urgent need of repair. When pouring the left plinth block, the builders either miscalculated the required concrete volume (and the prepared mix was insufficient) or part of the front layer fell off due to premature formwork removal. They didn't bother to correct it and just left it as is. The wall above the trilithon block is built with a gross violation of the block bonding. In the seismically active region of Lebanon, such a wall can only withstand earthquakes if its stone blocks are secured to one another with steel rods. Photo 2019 from [wikimedia.org](https://commons.wikimedia.org/wiki/File:Trilithon_of_Baalbek.jpg).

A significant part of the outer concrete layer on the front side of the south trilithon block has fallen off, making this layer noticeably thinner than it originally was (see Photo. 10). A little more and the interesting internal contents of the “monolith” will be revealed. It appears that this Humanity's World Heritage urgently needs repair. The destruction of the outer layer occurred due to the insufficient strength of the concrete and the improper placement of the overlying wall blocks. Unlike the north and middle trilithon blocks, the wall blocks placed above the south block exerted their weight also on the front concrete layer (and apparently continue to exert pressure today on the remaining parts of this layer).

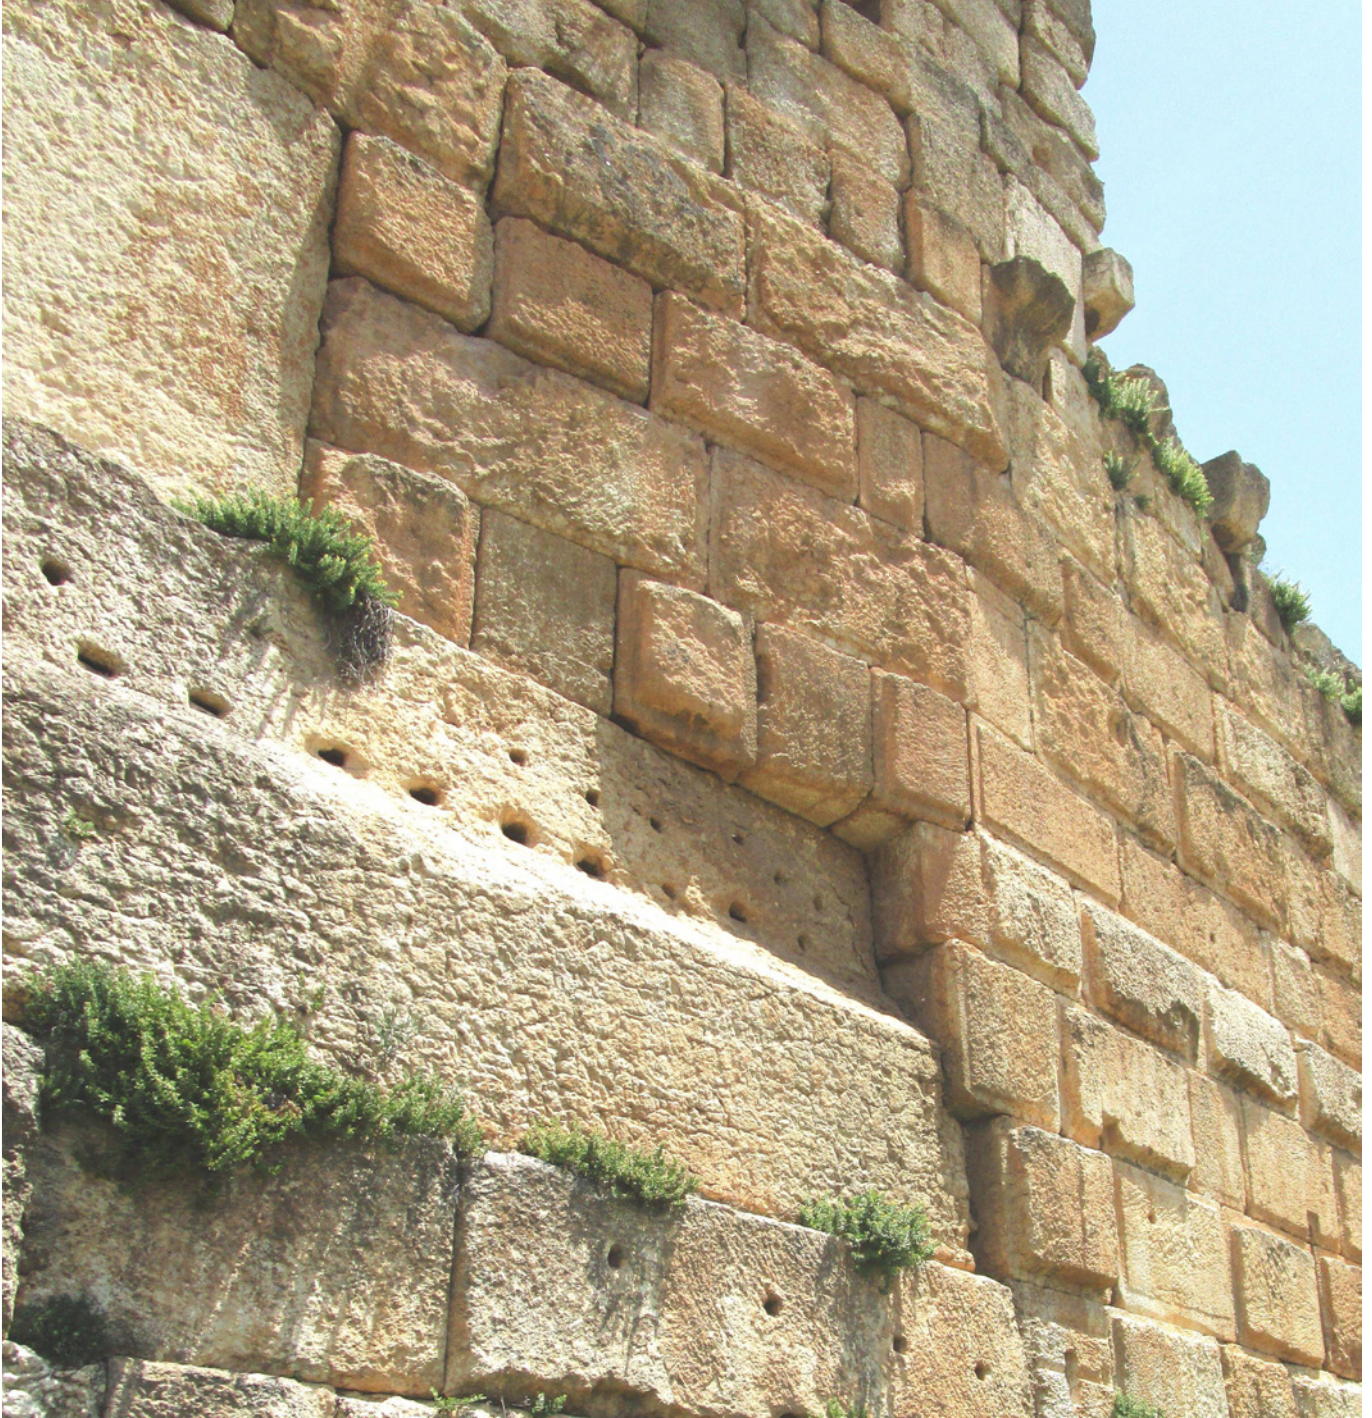
Photo. 11. Places where the stone blocks of the fortress wall adjoin the sides of the south trilithon block and the plinth block located beneath it. A number of features – the violations of the block bonding and stretcher masonry pattern in the fortress wall; the use of the L-shaped recesses; the adjustment of stone height by cutting away the marginal areas of the face dressing; the formation of a “cornice” of overhanging blocks; the presence of a large gap between the end of the plinth block and one of the stone of the fortress wall; and the location of the tower inside rather than outside the fortress wall – all indicate that the plinth block and the trilithon block were formed within a pre-existing medieval fortress. Such formation led to a substantial reconstruction of the tower at the southwest corner of the podium and to the outward relocation of the fortress walls adjoining this tower. Photo 2019 from wikimedia.org.
