Analysis, presumed structure, method and time of fabrication of the Baalbek trilithon and “tired” parallelepipeds

Rostislav V. Lapshin

Kurchatov Institute

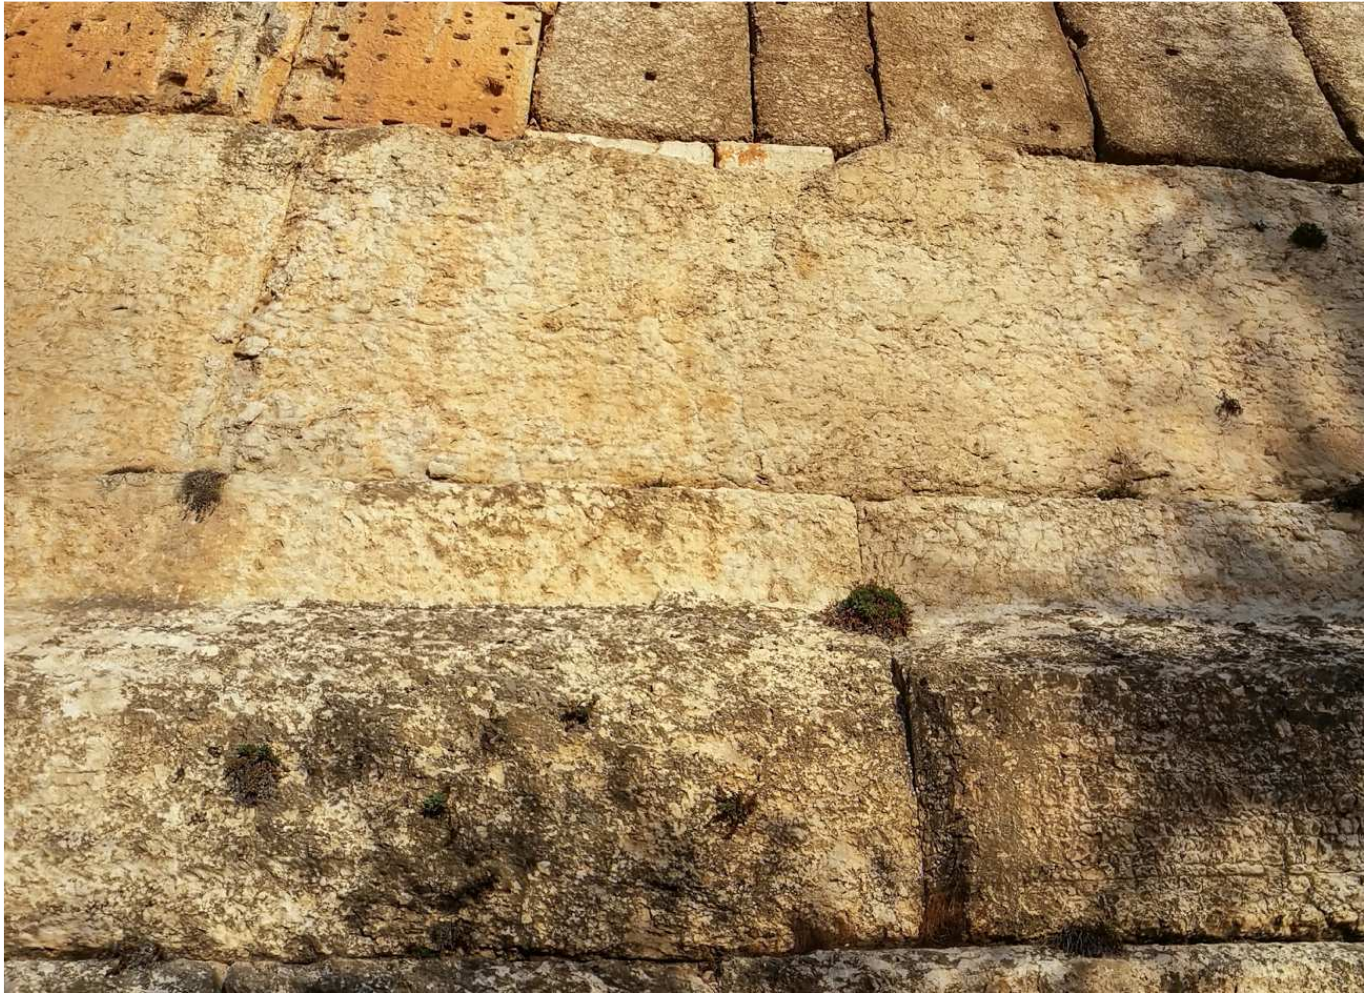
Photo. 12. Left third of the middle trilithon block. In the area of the upper horizontal edge, not far from the upper left corner of the trilithon block, a small fragment of the outer concrete layer has spalled off (or possibly there was insufficient concrete during pouring). As a result, the tops of two relatively small stone blocks of the fortress wall – which had been relocated here from its original construction site on the west side of the small podium – became exposed. It turns out that the trilithon blocks are in fact concrete boxes encasing masonries made of relatively small and quite transportable stone blocks like these. Photo by the Laboratory of Alternative History, 2016, lah.ru.

haul either from the quarry to the construction site. Of course, all this impossibly heavy magnificence was created right here, on the spot. Evidence of this can be observed in the region of the upper horizontal edge of the middle trilithon block (not far from its upper left corner, see Photo. 12), where the tops of some strange pair of blocks of very modest sizes are peeking out.

Judging by these exposed tops, the trilithon blocks are in fact composed of such comparatively small stone blocks with a concrete layer poured over them in front, on the sides, and above. It is

clearly seen that the indicated pair of stones quite successfully copes with the weight of the wall above, whose “unbearable” weight the mighty trilithon blocks are supposed to carry. The stone blocks inside the trilithon blocks serve as a rigid filler,^{1,2} which is intended to significantly reduce the required volume of concrete, sharply decrease concrete shrinkage – thereby preventing the formation of shrinkage cracks – substantially simplify the formwork design, and also shorten the hardening time.

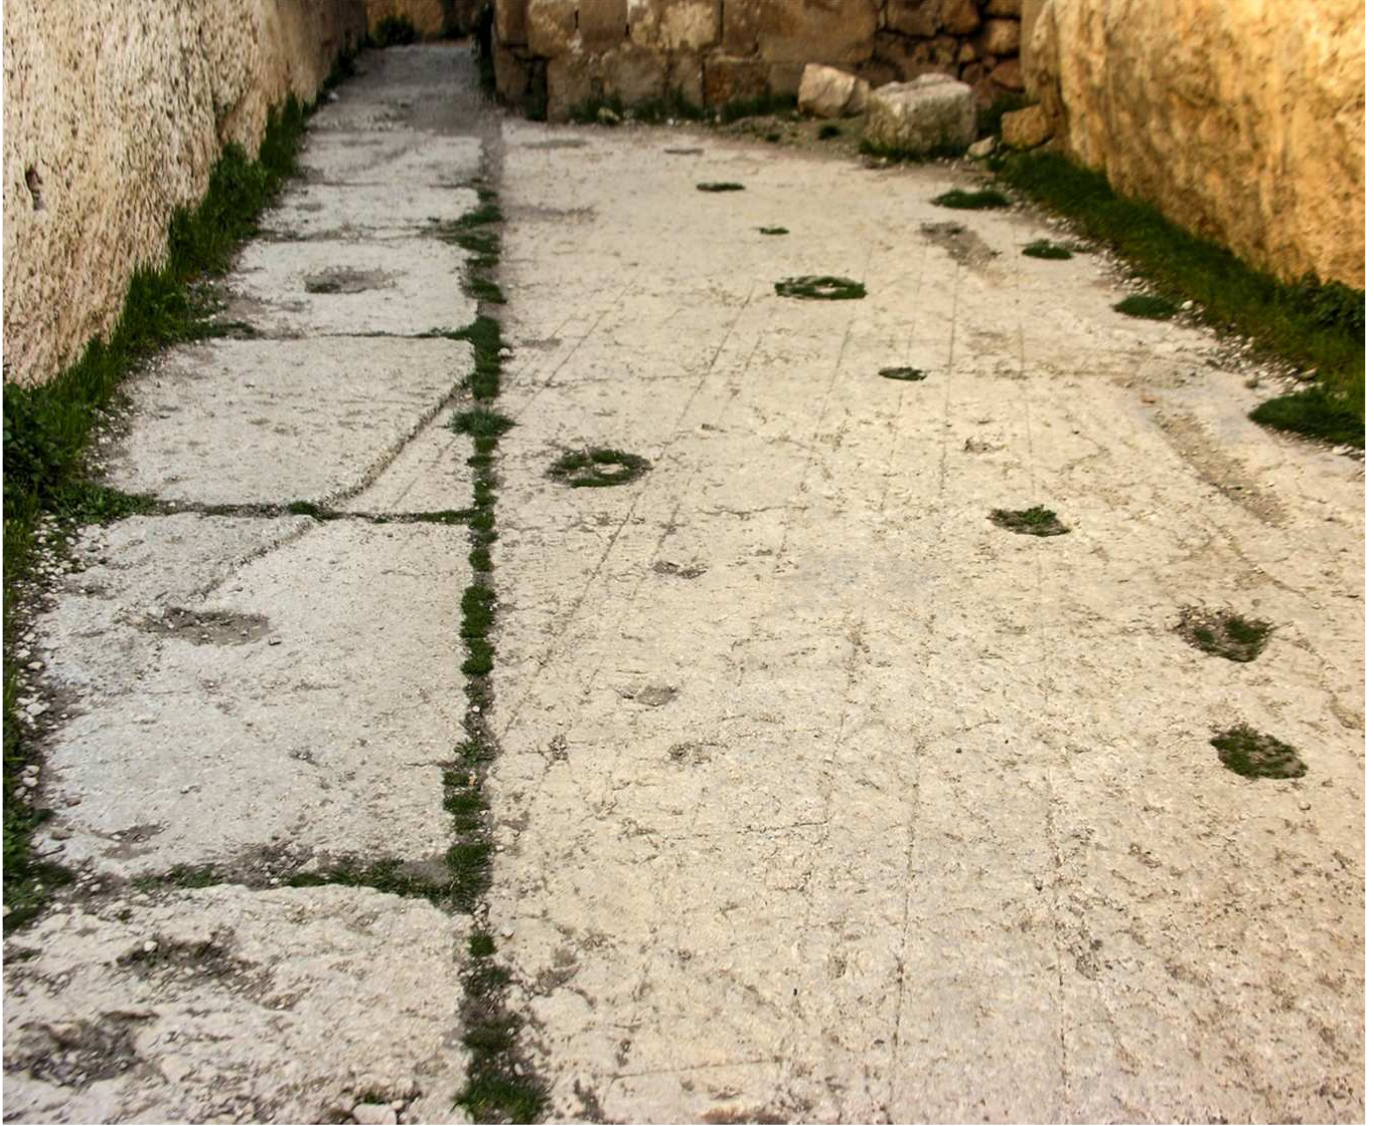
Photo. 13. The upper concrete layer of the south trilithon block (south is in front; the “fortress” wall is to the right). Rows of “mysterious” round and square pits represent the places where, during pouring, walkways were positioned on short supports made of round logs and squared beams. Workers moved along the walkways carrying out concrete pouring and compaction. Walkway supports stood on the stone masonries being filled with concrete. After the upper sealing concrete layer of the trilithon block had set, the walkways were dismantled, the walkway supports were extracted from the concrete “floor”, and the resulting depressions were filled with concrete. Owing to poor adhesion between the concrete and the depression walls, the concrete within the depressions gradually disintegrated over time, eventually resulting in the pits we observe today. The relatively small blocks in the row on the left, judging by the pits on their surface, were fabricated using the same concrete pouring technology as the trilithon blocks. Photo by unknown author.

Another piece of evidence for concrete pouring of the trilithon blocks is the rows of “mysterious” round and square pits on the upper faces of these blocks (see Photo. 13). During the pouring process, walkway supports were located at the positions of these pits. Workers moved by the walkways while performing concrete pouring and compaction. The walkway supports were put on upper faces of the stone masonries forming the core of the “megaliths”. After pouring and compaction of the sealing concrete layer of the upper face, the builders waited for its setting. After setting, the walkways were dismantled and the support posts were extracted from the con-

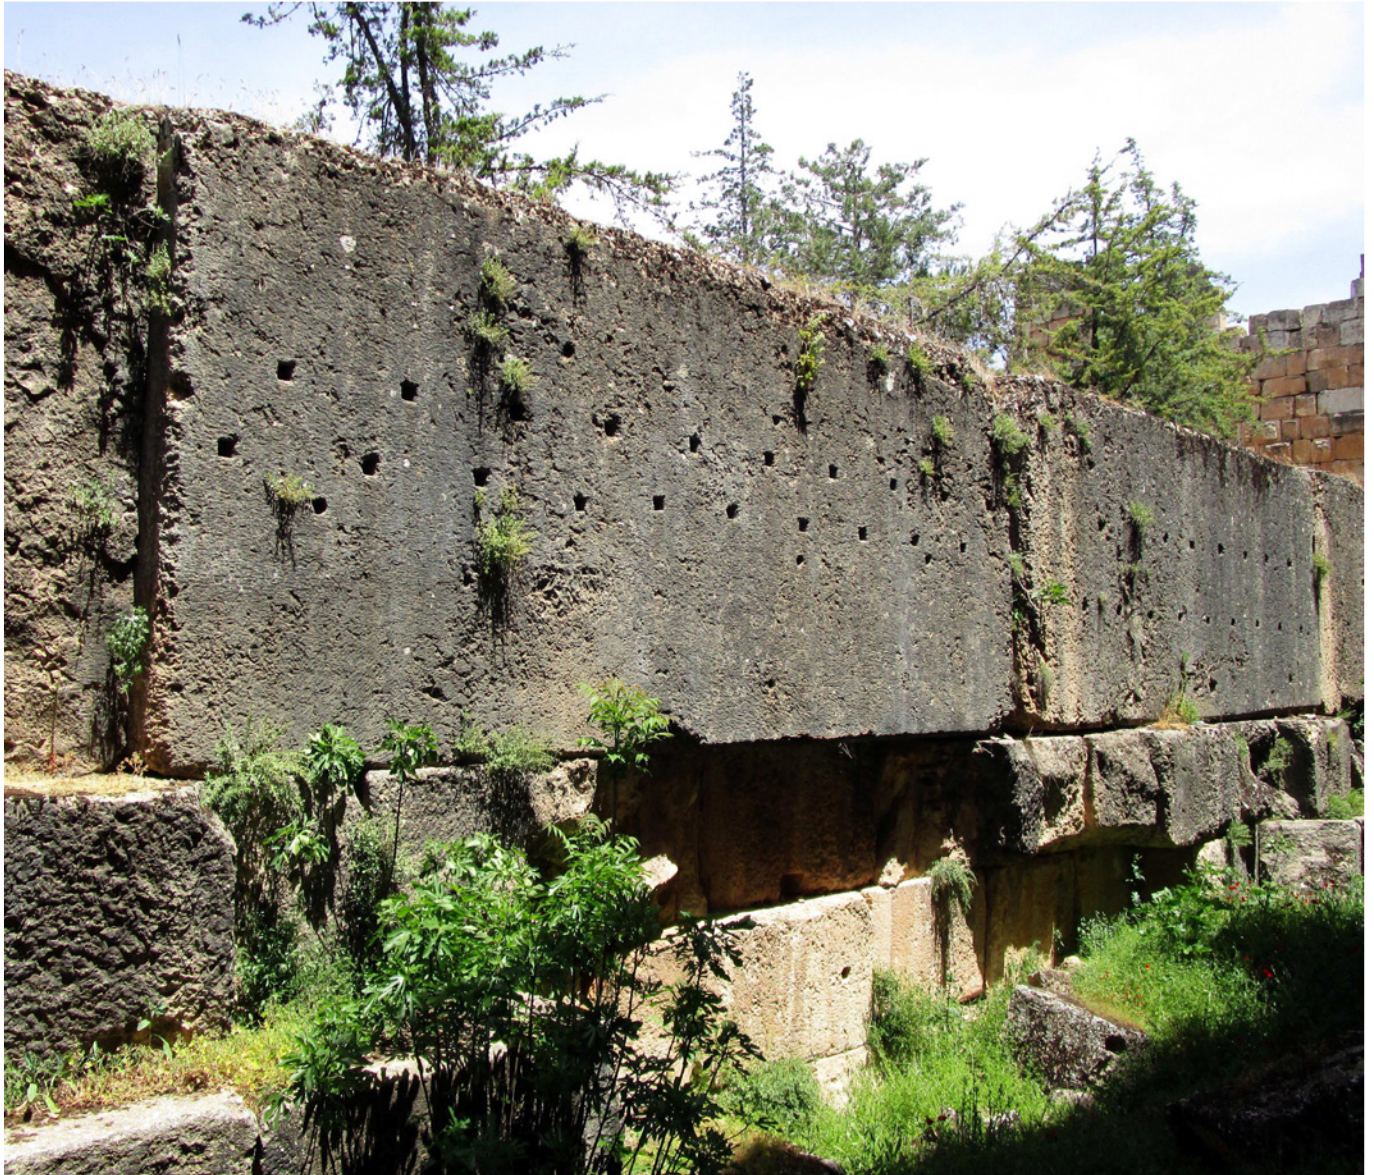
Photo. 14. Chain of plinth blocks forming the north side of the large podium, rear view. This example demonstrates that the systematically recurring “mysterious” square depressions were located not only on the front faces of the plinth blocks but also on their rear faces. The assumption that the square depressions served solely for installing anchors to secure facing slabs cannot be considered correct, since the rear sides of the plinth blocks were hardly intended to be clad. The masonry is laid with gross violations of the bonding rule; in addition, there is a section of a stretcher course laid with headers. Photo 2019 from wikimedia.org.

The plinth blocks on the west side of the large podium continue onto its north and south sides.¹⁹ The plinth blocks on the north side, set several meters away from the original fortress wall, were made in a highly careless manner. These blocks are supported by at least three courses of comparatively small blocks (see Photo. 14). In several places, the masonry of these blocks exhibits gross violations of the bonding rule (see Photo. 14, Photo. 15). There is a section of the stretcher course, visible from the fortress wall (see Photo. 14), which for some reason is laid with headers.

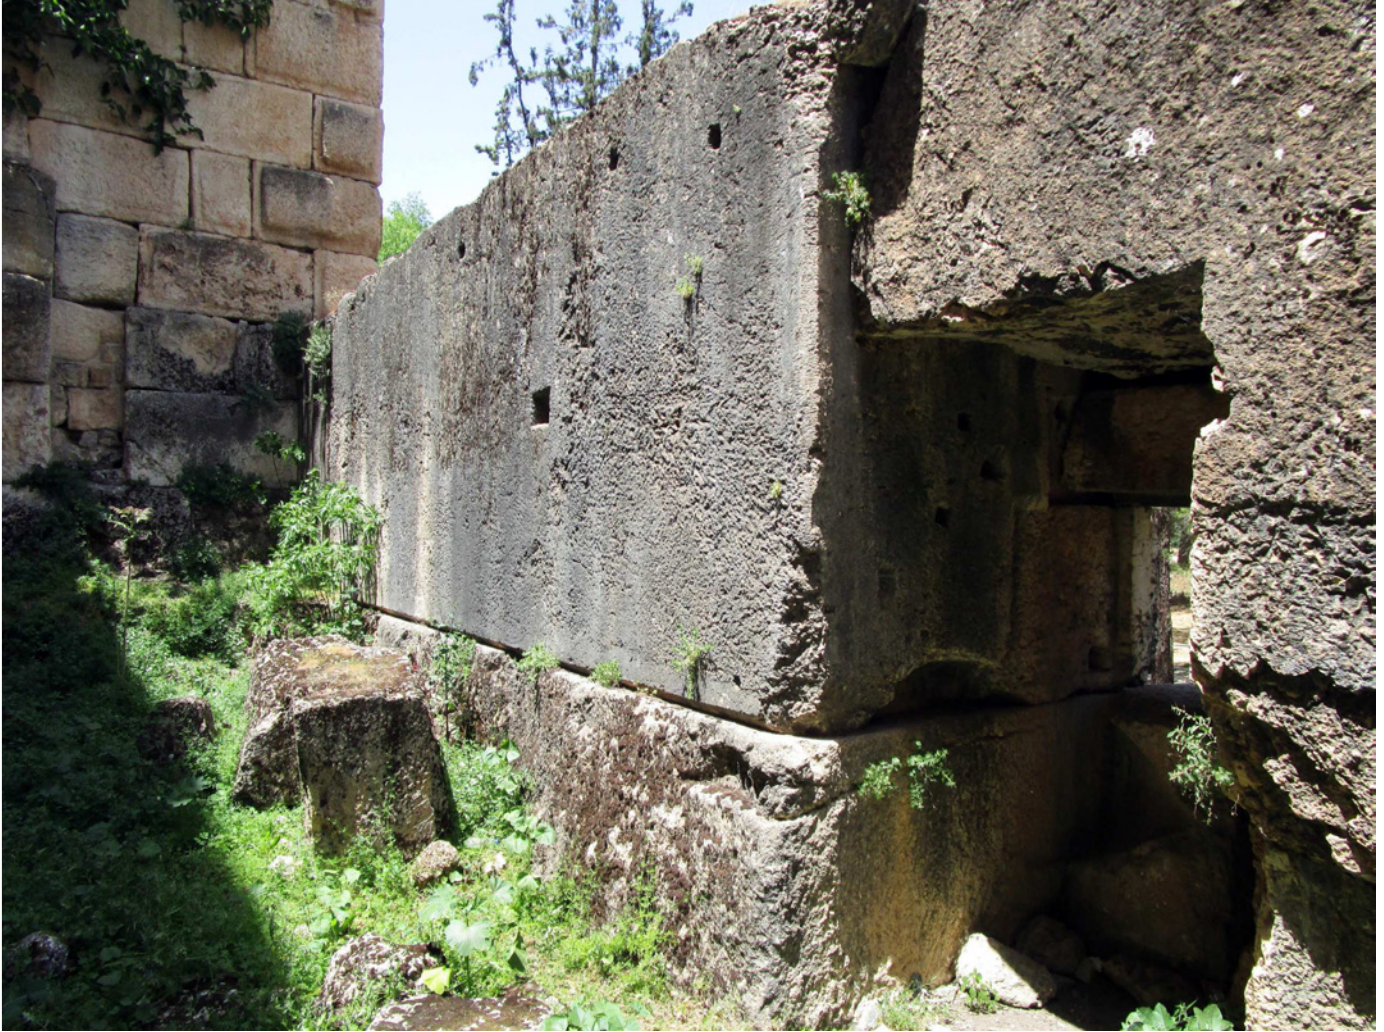
Photo. 15. Area of adjacency of a plinth block to the east side of the fortress tower positioned at the northwest corner of the large podium. The laying of the stone blocks forming the tower corner at the abutting area is the same as that found higher up in this area. The preservation of the tower wall block laying pattern indirectly indicates that the plinth blocks running along the north side of the tower were merely abutted to it. The plinth block abutting the tower wall end-on, together with similar blocks (the block to the right and those following it), are wider than the plinth blocks placed against the north tower wall by approximately the height of the stone blocks of which the tower is built. Photo 2019 from wikimedia.org.

The existence of the passage during construction is indicated by the square depressions preserved on the end of the adjacent plinth block (see Photo. 15 and Ref. 20). If the passage had been cut through later, as some researchers suppose, these depressions would have been filled with concrete. In the cross-section shown in Photo. 17, the remains of the outer concrete

Since the plinth block in Photo. 15 covers the end of the last plinth block running along the north side of the northwest tower, it is impossible to see whether the tower's stone blocks rest on the plinth blocks and to what extent the latter are embedded in the wall, or whether the plinth blocks, as we assume, are in fact merely placed against the tower. The arrangement of the plinth blocks in relation to the north and west walls of the tower can be attempted to be investigated by carefully examining the gap between these walls and the plinth blocks and probing it

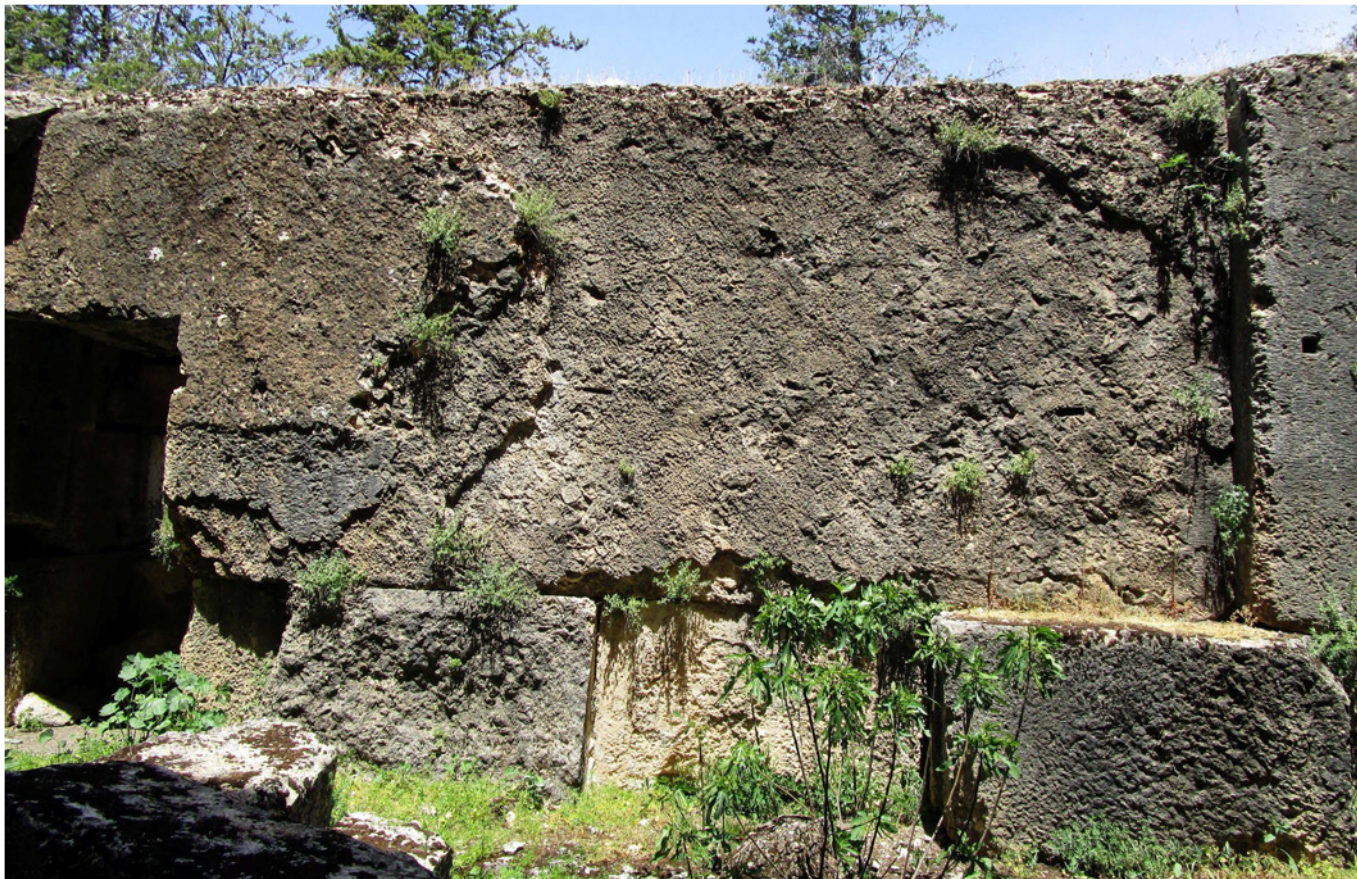
Photo. 16. Rear face of one of the plinth blocks on the north side of the large podium. The outer vertical concrete wall of this face has almost completely collapsed. The coarse gravel aggregate in the concrete filler did not settle at the bottom of the wall during pouring; instead, it is distributed more or less uniformly across all heights. On the left, where the wall has not yet fully collapsed, the remnants of square depressions are visible. The absence of the square depressions on the remaining surface indicates that their depth was equal to the thickness of the outer concrete layer of the wall. Photo 2019 from wikimedia.org.

In several places, the outer concrete casing of the plinth blocks has severely deteriorated due to the low quality of the concrete mix and the sloppy executed work. There are even plinth blocks whose rear vertical wall has almost entirely collapsed (see Photo. 16). The coarse gravel, which served as aggregate in the concrete used, is clearly visible in the remains of the collapsed wall. If what we are looking at is not concrete but natural limestone, does limestone from the known quarries of Baalbek really contain such large inclusions and in such quantities?

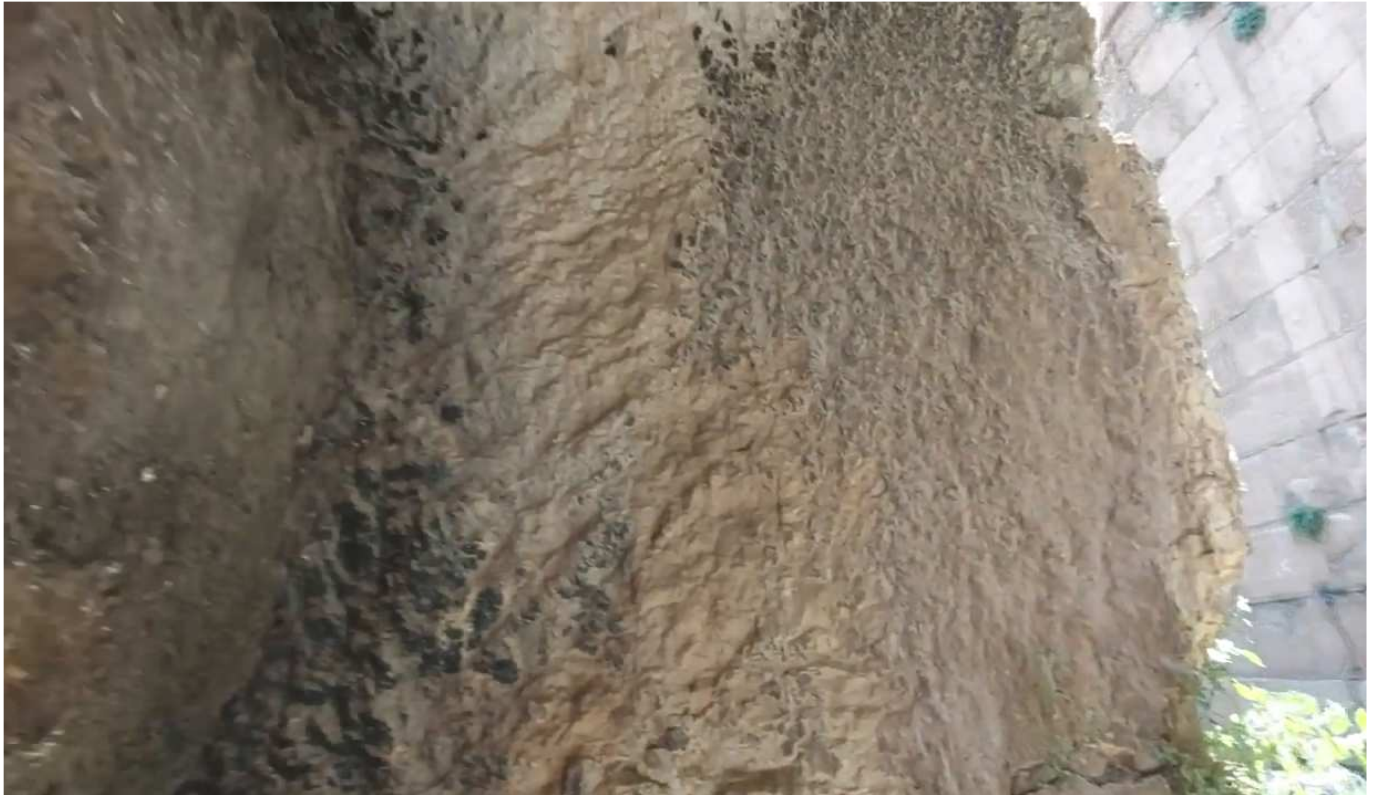
Photo. 17. Cross-sectional view of the plinth block from the side of the passage left by the builders. On the right, along the edge, remnants of the collapsed outer concrete wall are located; in the center – the internal concrete longitudinal partition. The darker areas to the left and right of the partition represent the internal masonry of stone blocks, which serve as a solid filler. Frame from the video “Showing inside the “megafence” of Baalbek”, 2023.

wall layer, as well as an internal longitudinal concrete partition, are clearly visible. The observed internal structure of the plinth block qualitatively replicates that of the West Stone (see Photo. 2a), revealed where a block had been cut out of its upper surface by someone.

The boundary between the stones of the internal masonry and the concrete walls/partitions is strongly blurred (see also Photo. 17). Firstly, the blurring occurs due to the specially left gaps

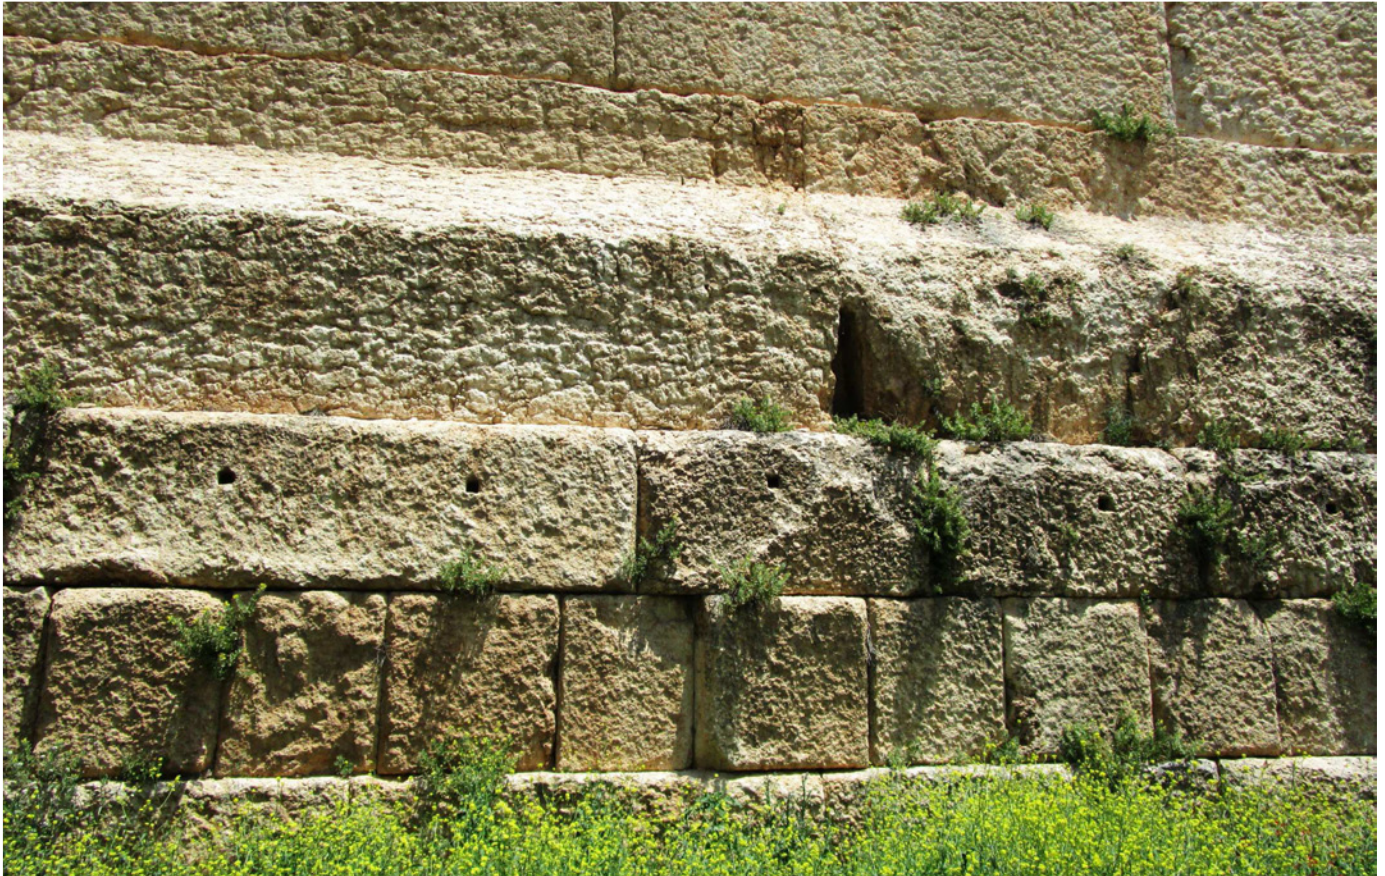
Photo. 18. Stretcher, header, and again stretcher courses of the stone blocks beneath the plinth blocks on the west side of the large podium. Since the header course on the north side becomes a stretcher course, and the stretcher courses become header courses, we are dealing with a typical wall construction one block thick, employing a single-course bonding pattern. In such masonry, the length of the stretcher in a header course equals twice the length of the header in a stretcher course. The length of the stretcher in a stretcher course is approximately equal to four times the length of the header in a header course. The heights of the blocks in stretcher and header courses of the masonry are unequal. The length of the header in a header course is approximately equal to the height of the stretcher course masonry. Photo 2019 from wikimedia.org.

Moving along the west side (see Photo. 18, Photo. 9a) and turning around the northwest corner (see Photo. 9b²¹), one can notice that the stretcher course of blocks beneath the plinth blocks on the west side becomes a header course on the north side, while the header course of the west side lying beneath the stretcher course becomes a stretcher course on the north side. In

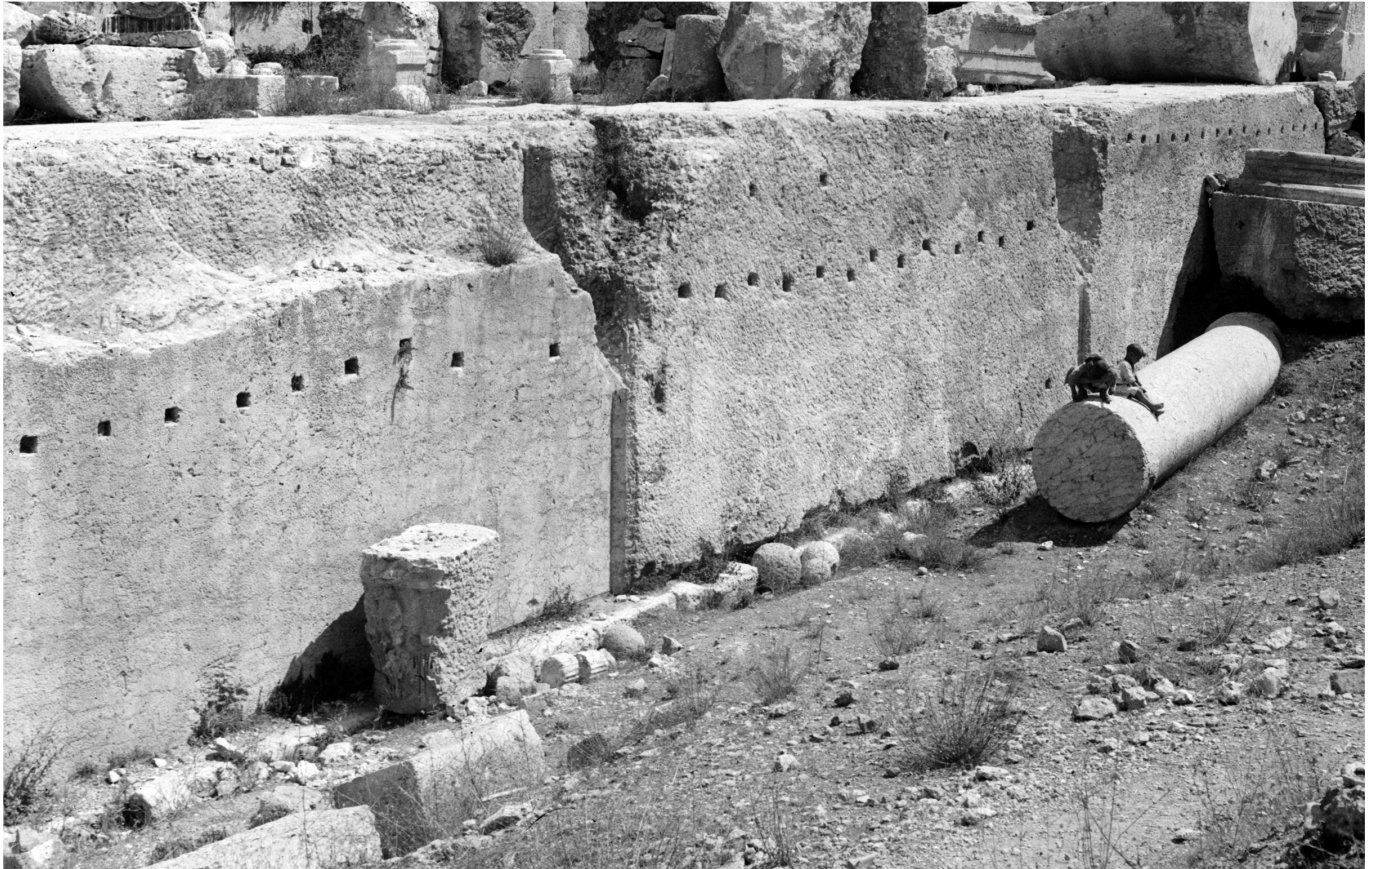
Photo. 19. Concrete plinth blocks on the south side of the Temple of Jupiter large podium. (a) The dimensions of the concrete platforms on which the plinth blocks stand are comparable in length to the bases of the blocks themselves, while exceeding them in width. At present, the concrete platforms are covered with earth and are not visible. The absence of a reliable foundation beneath the plinth blocks in the form of several courses of relatively large blocks indicates that further construction of the podium at this location in the complex was not originally planned. The giant podium is a late imitation. Photo from site of the Library of Congress, 1900, loc.gov.

Unlike the plinth blocks on the north side, the plinth blocks on the south side do not rest on any multi-course masonry of blocks beneath them; however, they are not laid directly on the ground either. If these blocks had no foundation whatsoever, they would hardly stand today as evenly as they did at the moment of their casting. If one looks at these blocks today, it gives the im-

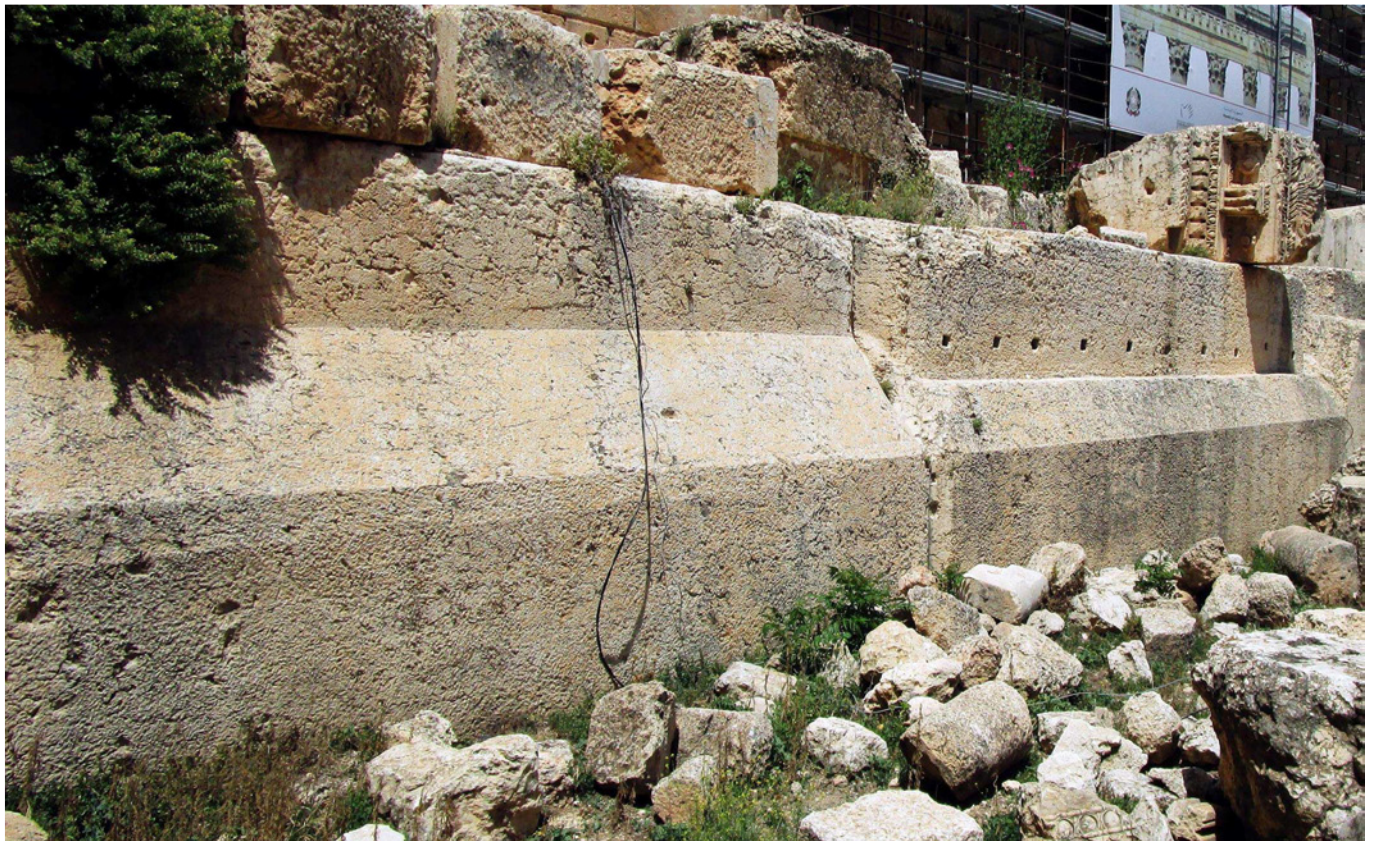
Continuation of Photo. 19. (a), (b) Even from the characteristic external appearance of the blocks (perfectly even, smooth, flat faces of large area), it is clearly evident that they were never hewn from any stone and never transported from any quarry – they were fabricated on site by casting concrete into a form. Photo 2019 from wikimedia.org.

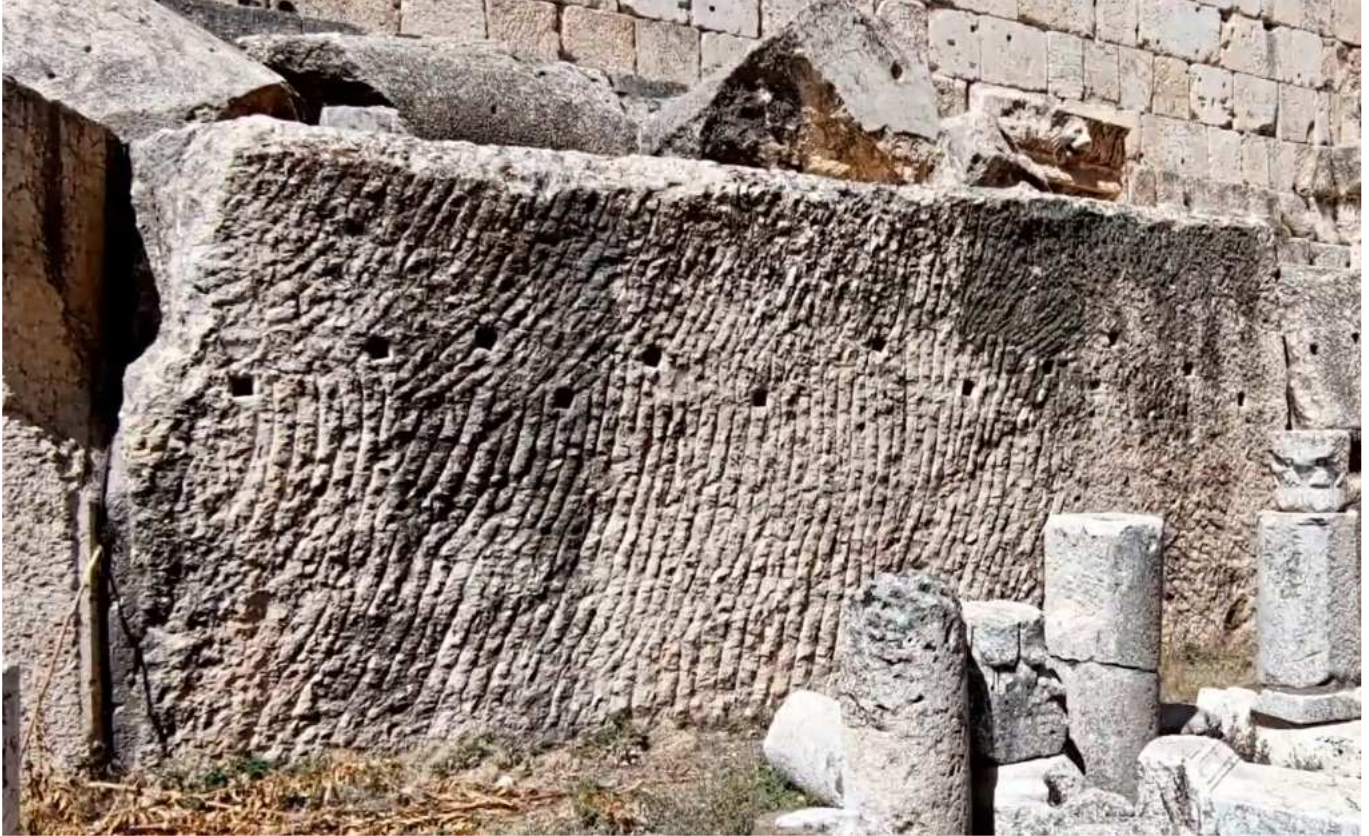
Continuation of Photo. 19. (c) Completely “impossible”, according to some researchers, long parallel grooves on the plinth blocks. By crudely scoring long grooves to imitate stone quarrying and/or surface preparation for cladding, the falsifiers attempted to conceal the obvious signs of concrete casting. Since the scholarly community of historians and archaeologists obediently keeps silent, bashfully looking away, and the general public largely fails to notice, the falsifiers decided not to bother processing the remaining plinth blocks in the same manner, limiting themselves to just one pair. Frame from the video “Lebanon, Baalbek”, 2024.

for the last point is provided by the grooves picked into the surface of some plinth blocks after casting (see Photo. 19c).

Suspicious regarding the concrete casting of the tired parallelepipeds intensified when the vertical faces of the parallelepipeds and the vertical walls of the “pedestals” beneath them turned out to be processed, firstly, with high quality (no rough pick marks are present; compare with Photo. 19c) and, secondly, with uniformly high quality (see Photo. 5). Neither of these phenomena should occur in the case of mechanical quarrying of monoliths directly from the rock outcrop.

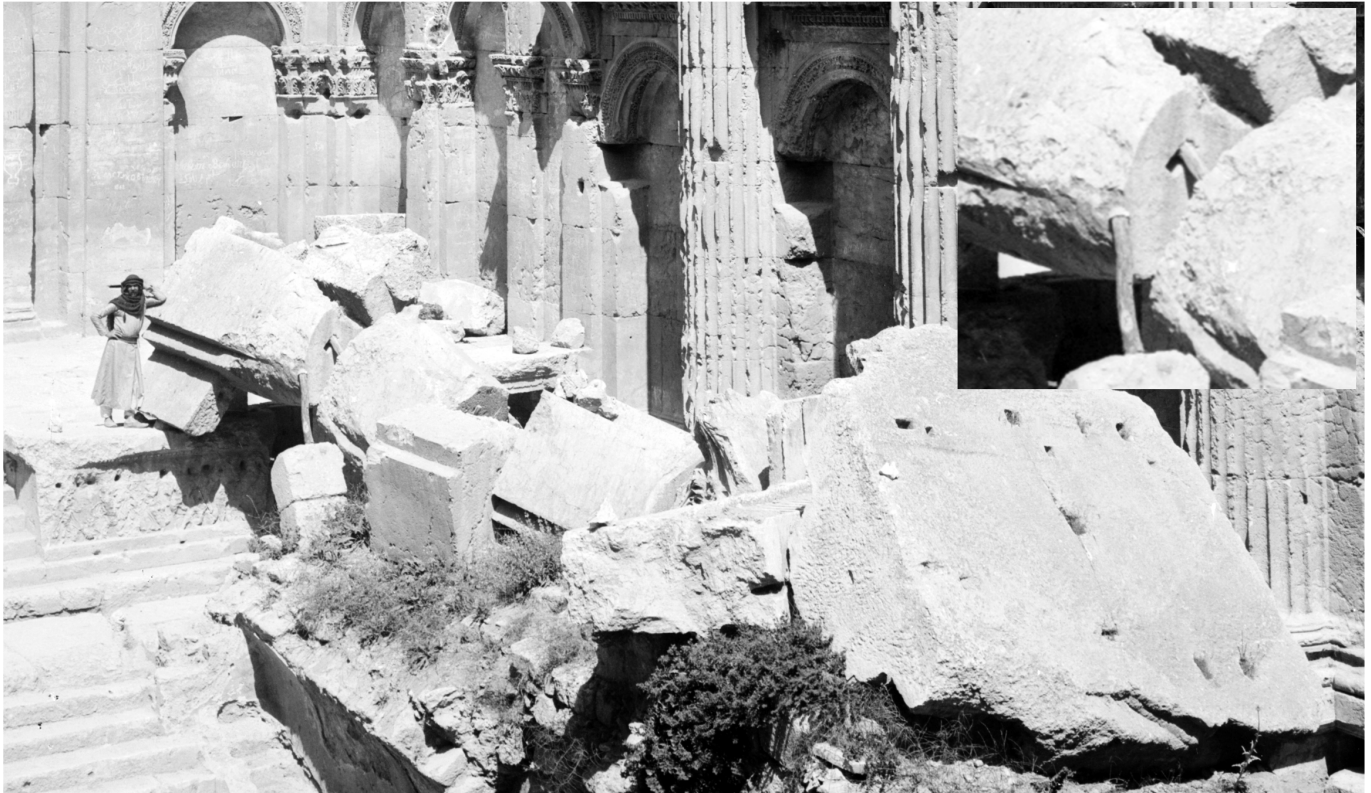
Photo. 20. A collapsed construction element in the Temple of Bacchus with “mysterious” rectangular and square holes from which protrude long metal reinforcing bars of large cross-sections (see the end face of the farthest block from us). Judging by the volumes of concrete casting and the type of reinforcement used, the “ancient Roman” temple was erected in the era of industrial production of iron and large-scale products of it. Photo from site of the Library of Congress, 1898, loc.gov.

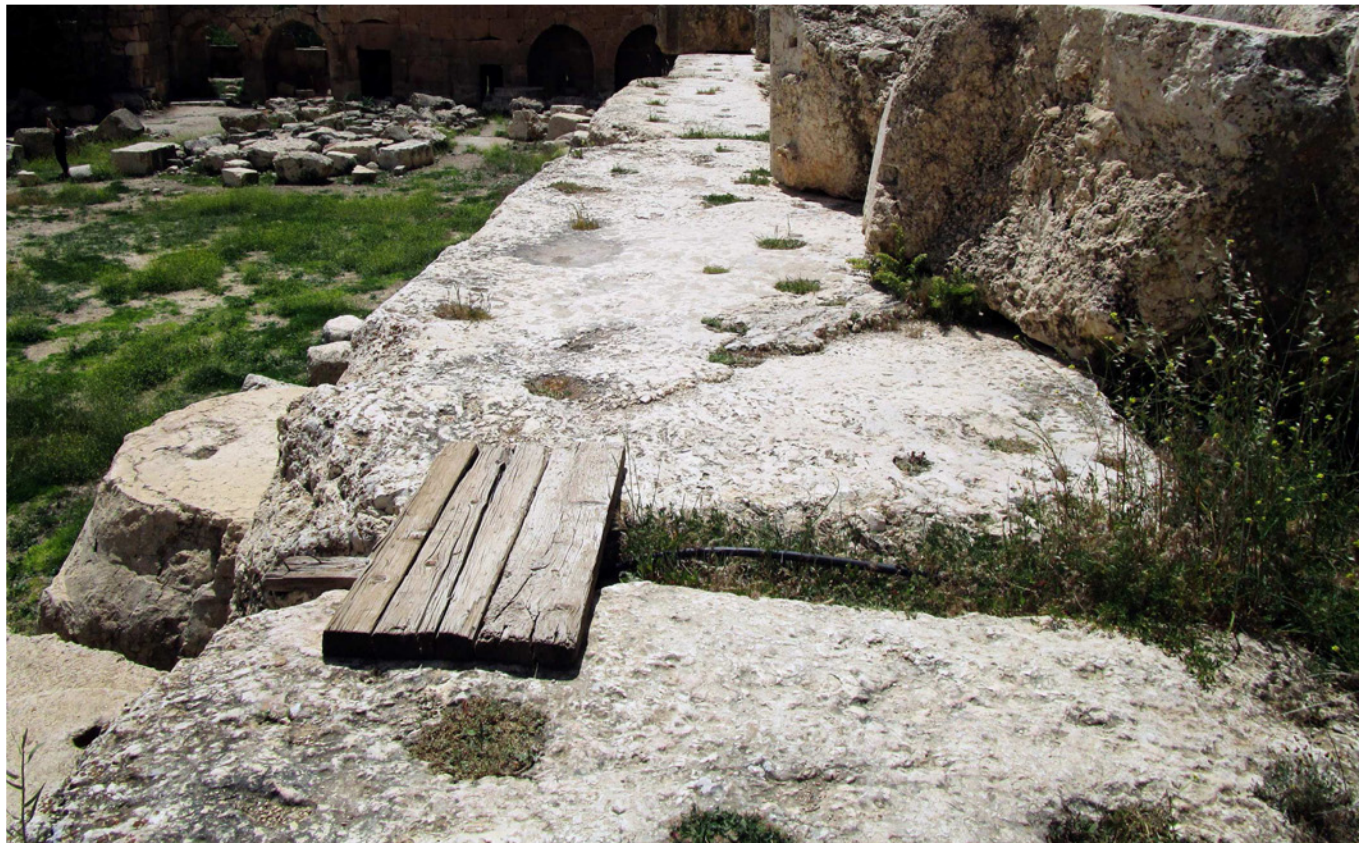
Photo. 21. Round and square pits on the upper faces of the plinth blocks on the south side of the large podium. The reason for the formation of these pits is exactly the same as for the pits on the upper faces of the tired parallelepipeds and trilithon blocks: the supports of the walkways from which the workers carried out the pouring and compaction of concrete. The supports were placed on top of the internal stone masonries that were being filled with concrete. On the plinth in the center, a fold characteristic of concrete casting is visible. Photo 2019 from wikimedia.org.
